Figure 3C-6.
Areas Inundated during Channel
Maintenance Flows - Rush Creek
Bottomlands

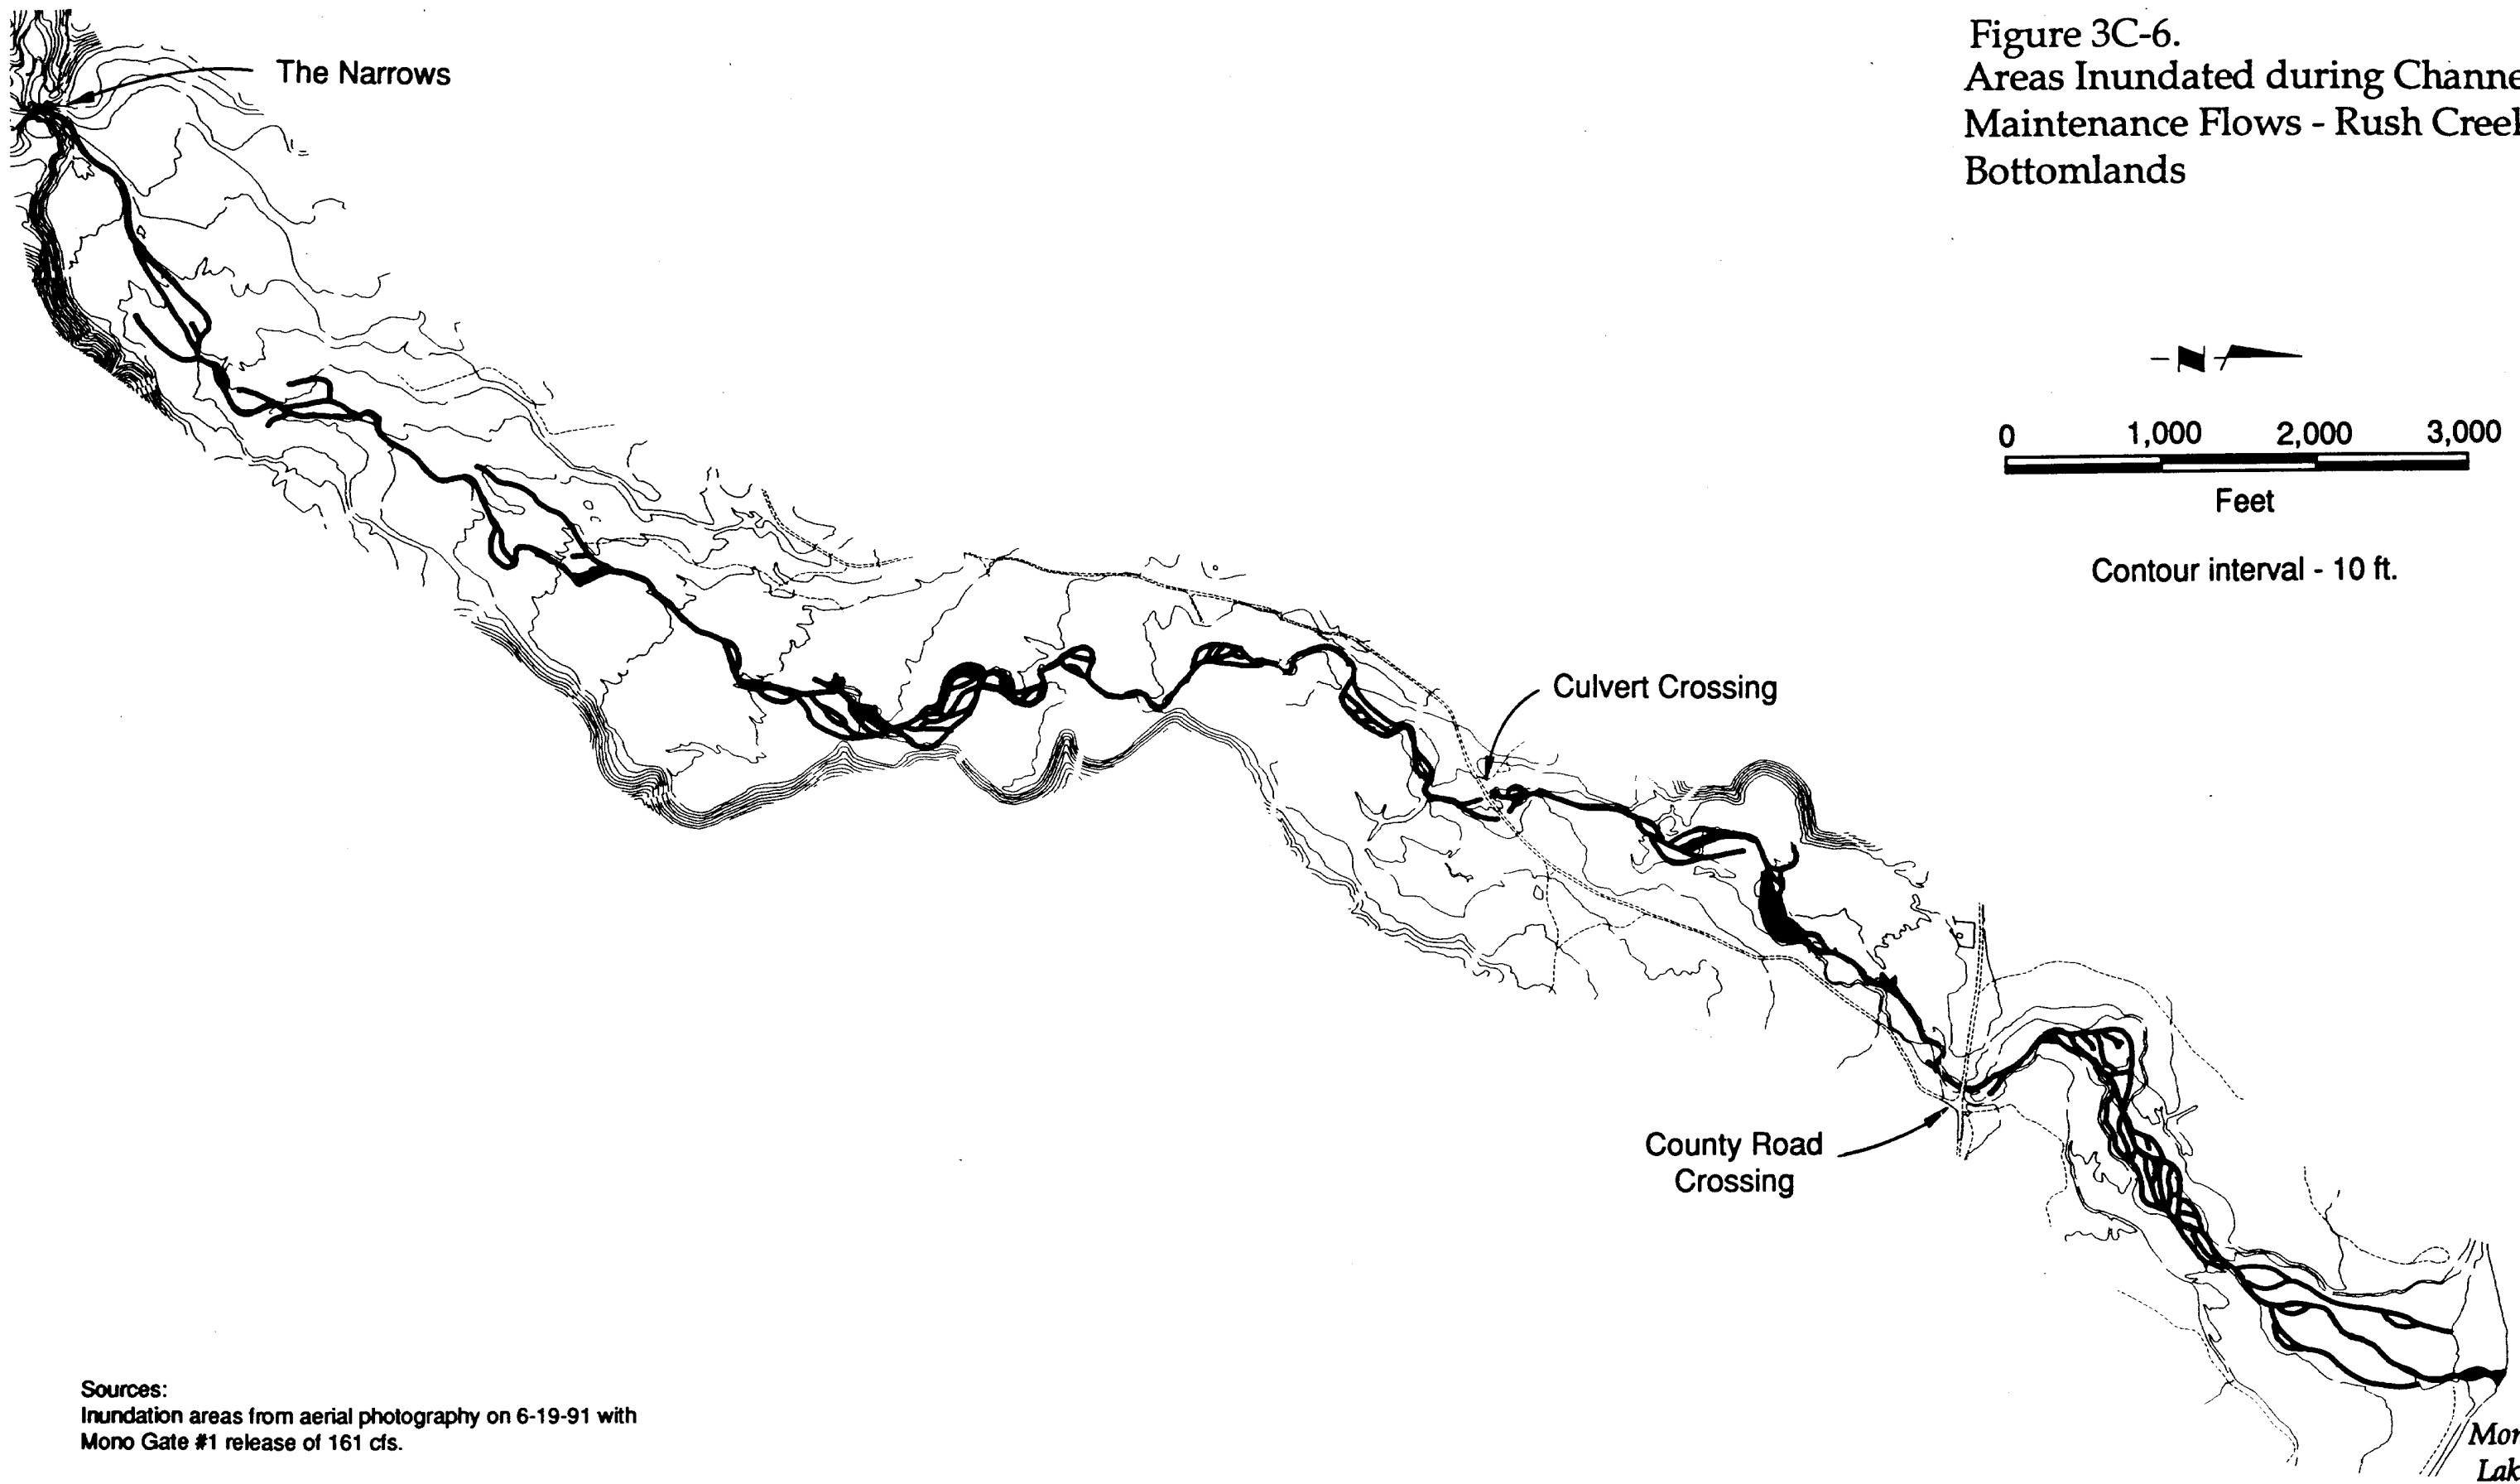
Sources:
Inundation areas from aerial photography on 6-19-91 with
Mono Gate #1 release of 161 cfs.

Topography from photogrammetry by Aerial Photometrics
from 5-6-91 photographs; original contour interval is 2 feet.
