**Mono Basin Tributaries:
Lee Vining, Rush, Walker, and Parker Creeks**

**Monitoring Results and Analysis
For Runoff Season 2006-2007**

Prepared for:
Los Angeles Department of Water and Power

Prepared by:
McBain & Trush
P.O. Box 663
Arcata, CA 95518
(707) 826-7794

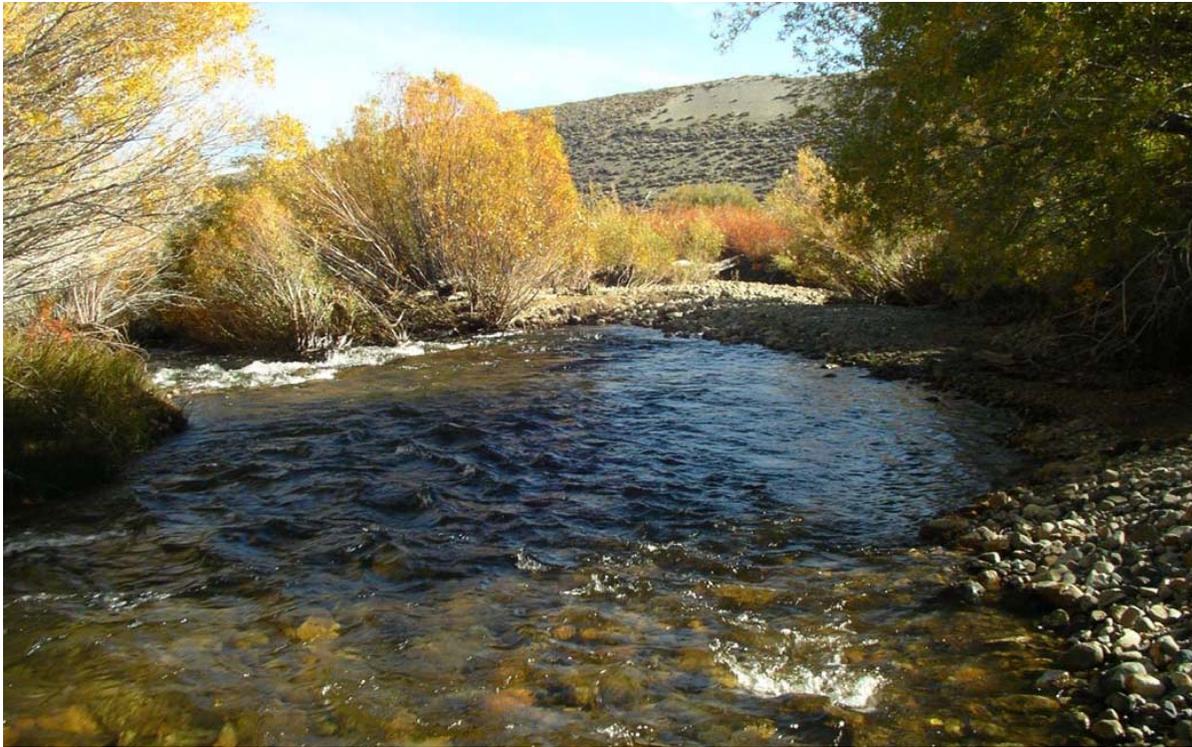
Figure 9. Side-channel entrance closed off from the RY 2006-07 snowmelt release.

Downstream of the 4bii Channel entrance, at the next broad meander bend with split channel, the entrance to the right side-channel aggraded and cutoff flow into the right channel (Figure 9). The right side-channel was mostly dry in October 2006, with only ponded water in deep pools.

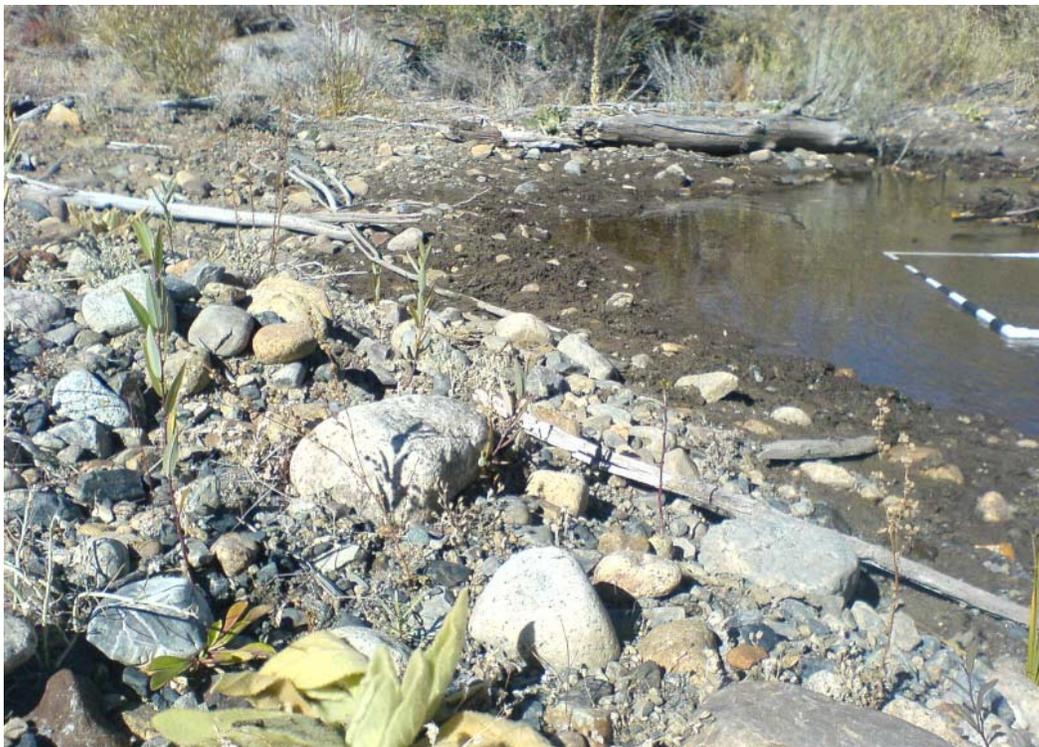
Figure 15. Narrowleaf and yellow willow seedlings growing along the 8 Channel near the entrance. Date of photo: October 19, 2006.

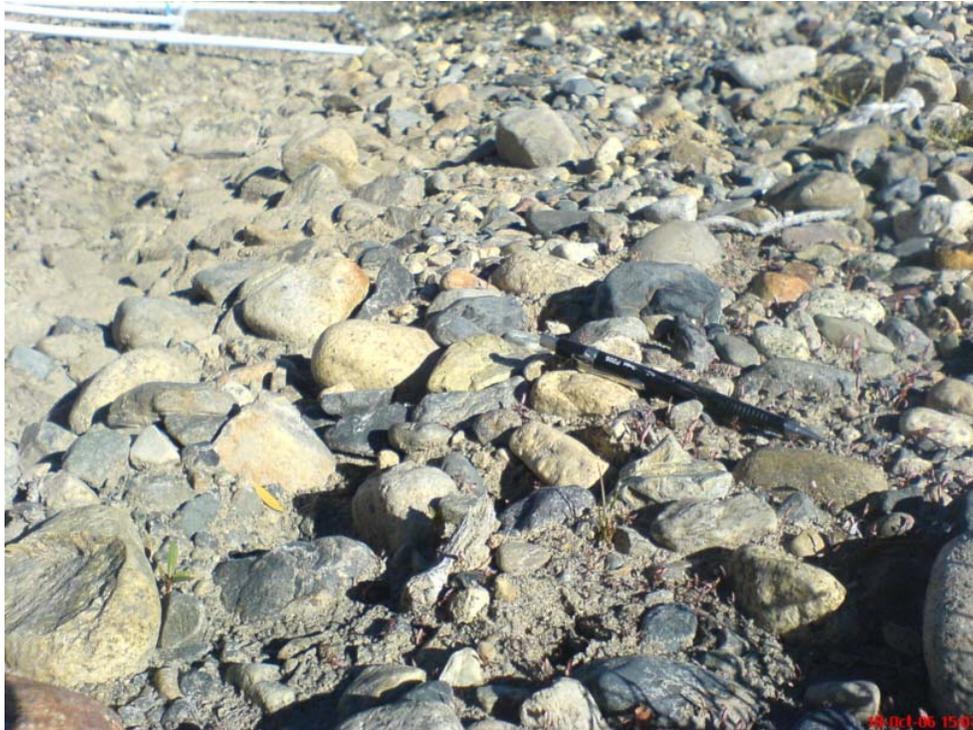
Figure 16. Dead and surviving cottonwood and willow seedlings along the 8 Channel at the downstream end. Date of photo: October 19, 2006.

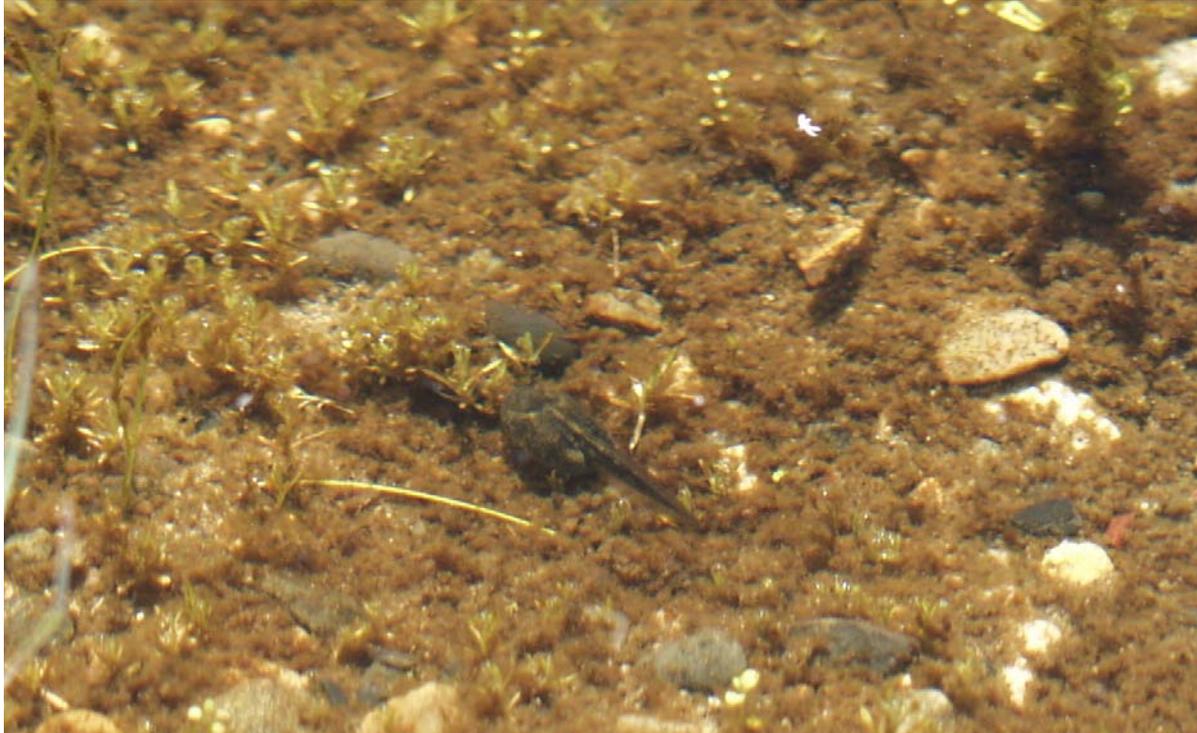
Figure 17. Desert toad tadpoles (*Bufos punctatus*) in the wetted 8 Channel July 16, 2006.

Red spotted or Desert Toad (*Bufos punctatus*) tadpoles were observed in the 8 Channel below piezometer 8C-8 in July 2006 (Figure 17), indicating ponded water had persisted long enough on the floodplain for an amphibian species to complete early stages of its life cycle.

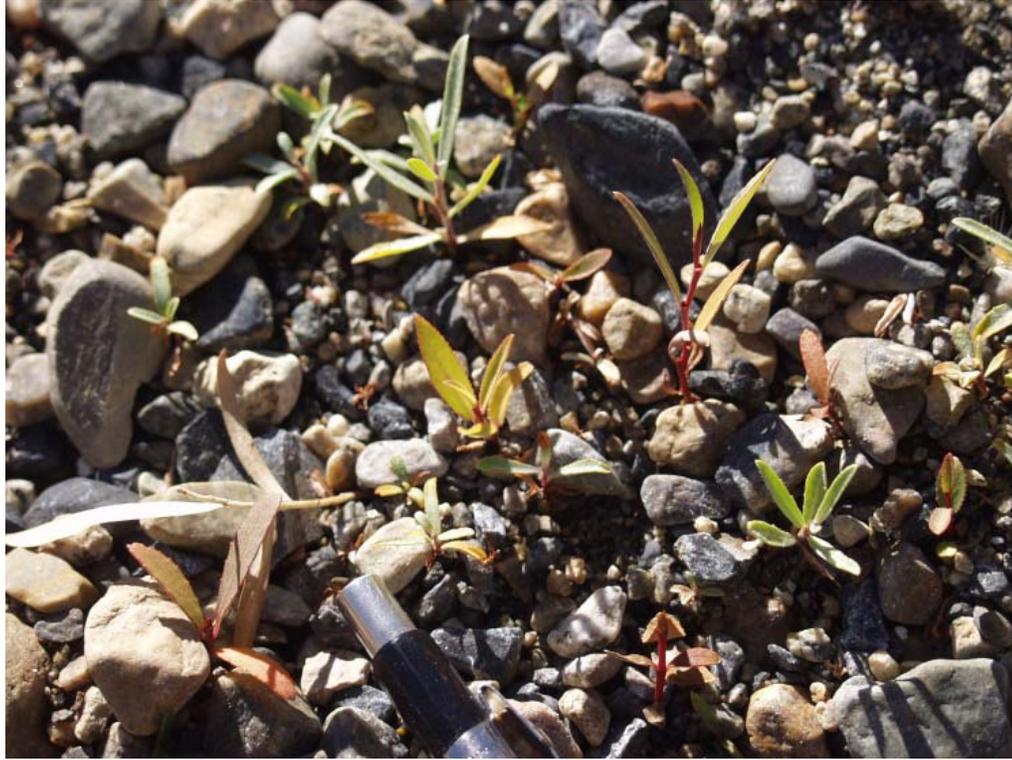
Figure 19. Black cottonwood (*Populus balsamifera* ssp. *trichocarpa*), yellow willow (*Salix lutea*), and narrowleaf willow (*Salix exigua*) seedlings that initiated on the 4 Floodplain in RY 2006. Date of photo: October 19, 2006.

Despite difficulties in detecting seedlings because of their size (Figure 19), many willow and cottonwood seedlings germinated and survived on the 4 and 8 floodplains. Yellow willow (*Salix lutea*), the most common riparian woody plant in the Rush Creek riparian corridor, had the highest densities of seedlings at the 4 and 8 floodplains. Black cottonwood was the second most frequently observed species, with highest seedling densities clustered near female trees then dropping off sharply approximately 300 ft from the source tree. Cottonwood seedlings were also found on open areas adjacent the 4bii Channel along the right valley wall. If an area was open and saturated in July, willow and cottonwood seeds (depending on which species was closest) likely germinated and survived into the fall.

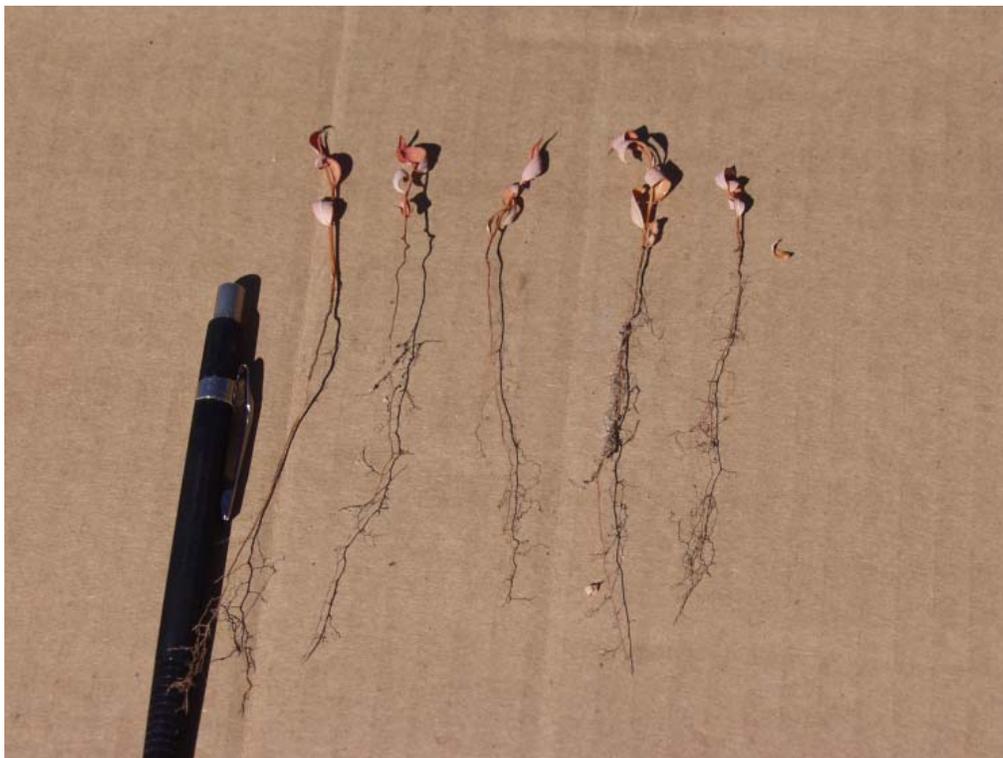
Figure 20. Dead yellow willow seedlings dug up on the 4 Floodplain showing root lengths.

In a few locations where dead seedlings were mapped, individual seedlings were dug up and the distance to visible soil moisture measured. We questioned whether (1) lack of soil moisture caused the seedlings to desiccate, or (2) maximum daily air temperatures had “cooked” the seedlings. Most seedlings had grown roots of similar lengths (Figure 20), suggesting soil moisture conditions were fairly uniform when seedling mortality occurred. When the seedlings were excavated in October, soil moisture was visible within 0.2 ft of the ground surface and all the dead seedlings’ roots had grown deep enough to access this water source (Figure 21). Based on similar work we have done on the Trinity River in Northern California, we surmised that the soil moisture observed in October was not present when the seedlings died. Because of the dead seedling’s size, we estimated that they had died sometime between the high flows recession in July, and our sampling in October. Coincidentally, the 4bii Channel dried up briefly in late July and soil moisture likely declined beyond the seedling roots. In August, flows again accessed the 4bii Channel and rewetted the soil, which is the likely source for the soil moisture observed in October. We concluded that perennial flow in the 4bii Channel would have sustained soil moisture and facilitated the survival of these seedlings.

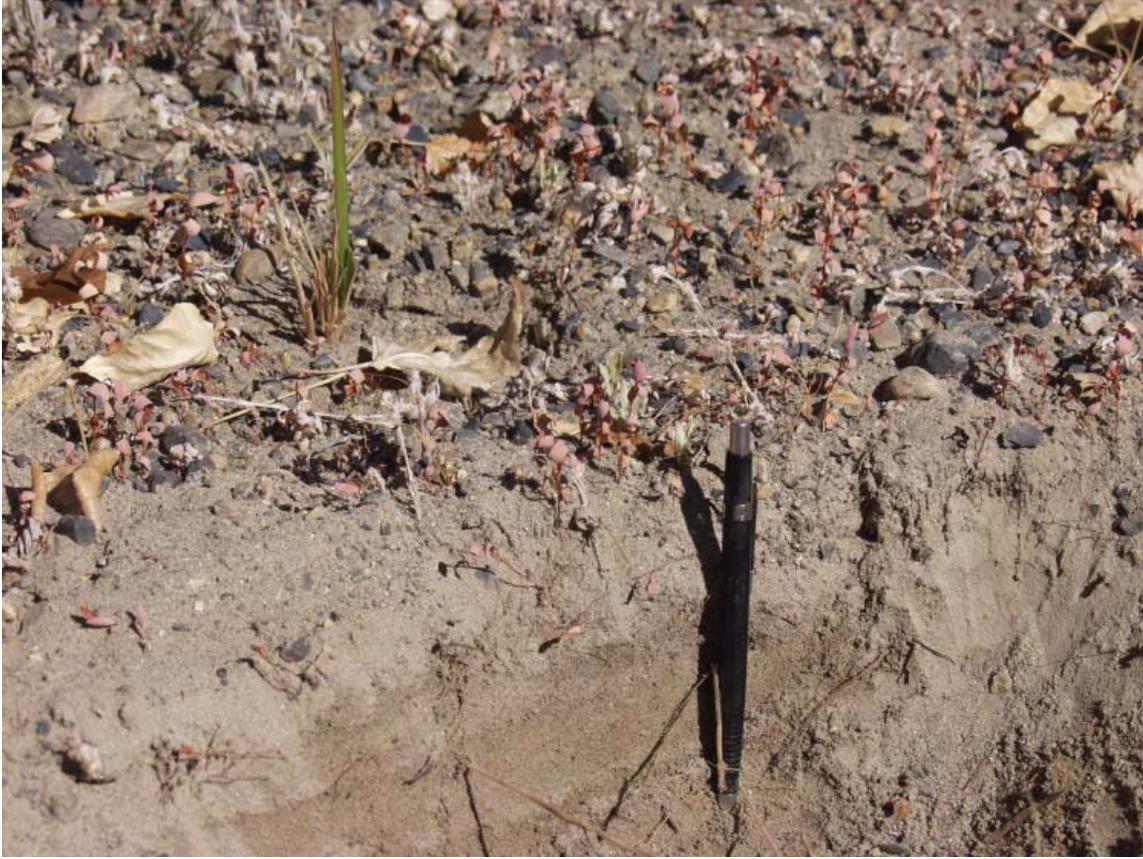
Figure 21. Soil pit showing soil moisture close to the ground surface in a field of dead yellow willow seedlings. Date of photo: October 19, 2006.
