MONO BASIN WATER RIGHTS EIR

Changes over Time in Geomorphic Conditions,
Sediment Transport and Riparian Cover
in the Owens River below Pleasant Valley
Dam, Inyo County, California

Thomas Hickson and Barry Hecht

Balance Hydrologics, Inc.

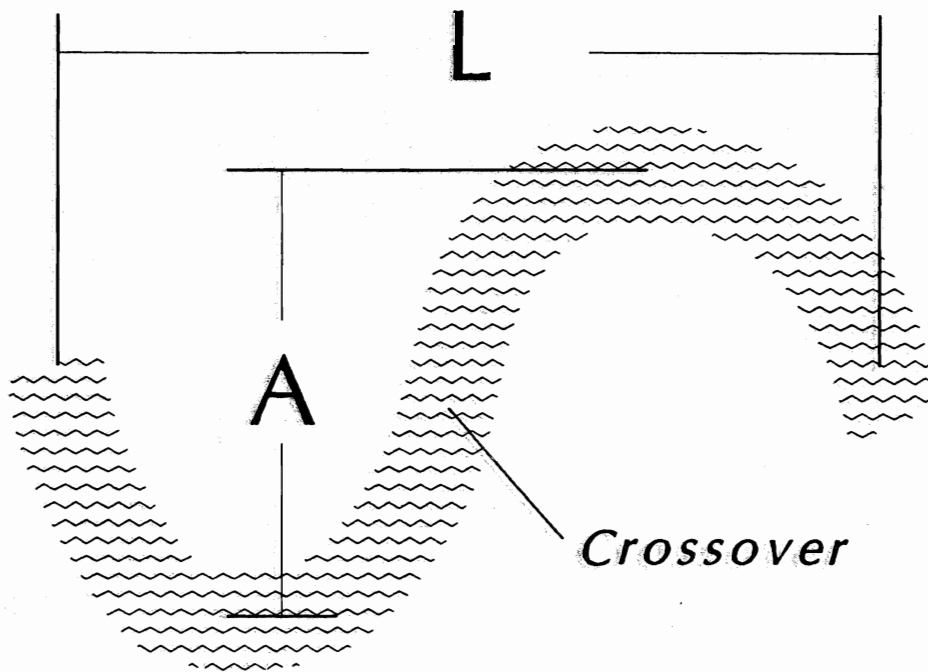
$L = \text{Meander wavelength}$

$A = \text{Meander amplitude}$

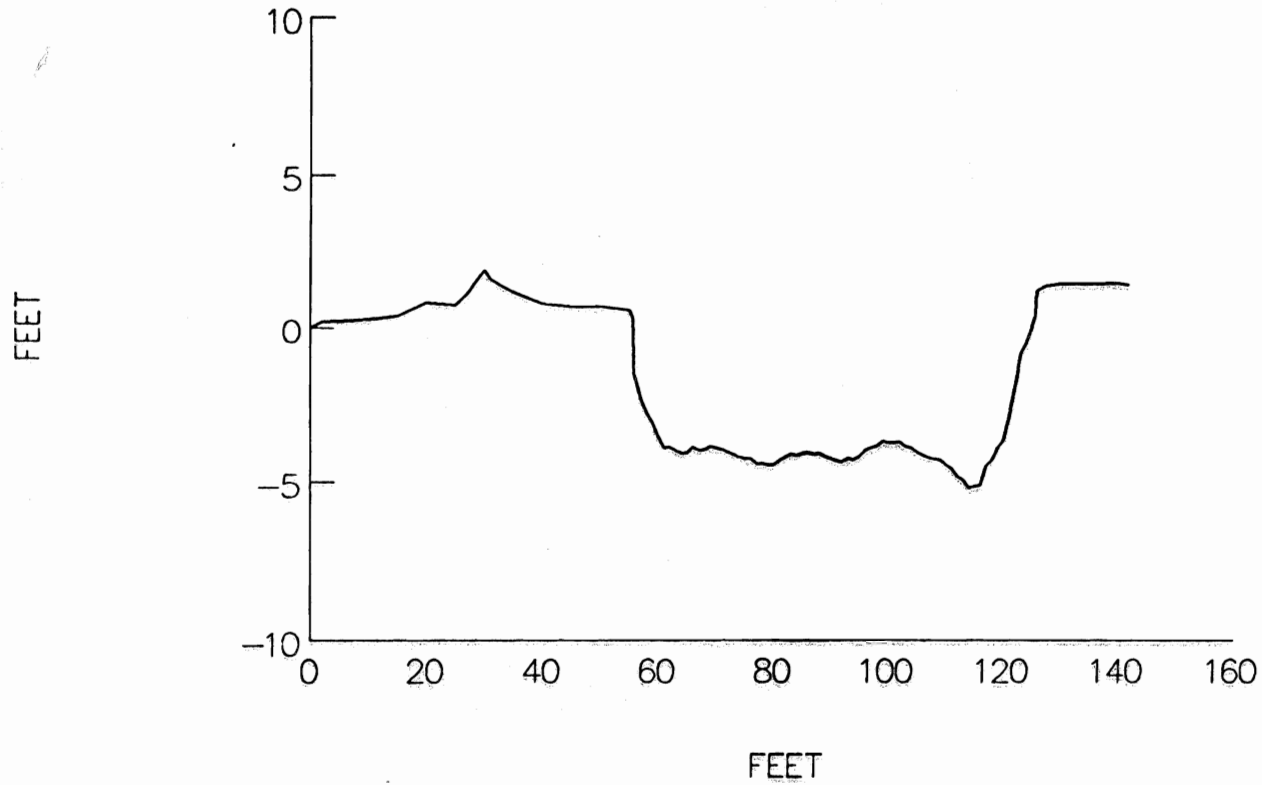
BALANCE SECTION 3A
OWENS RIVER, 05/23/91

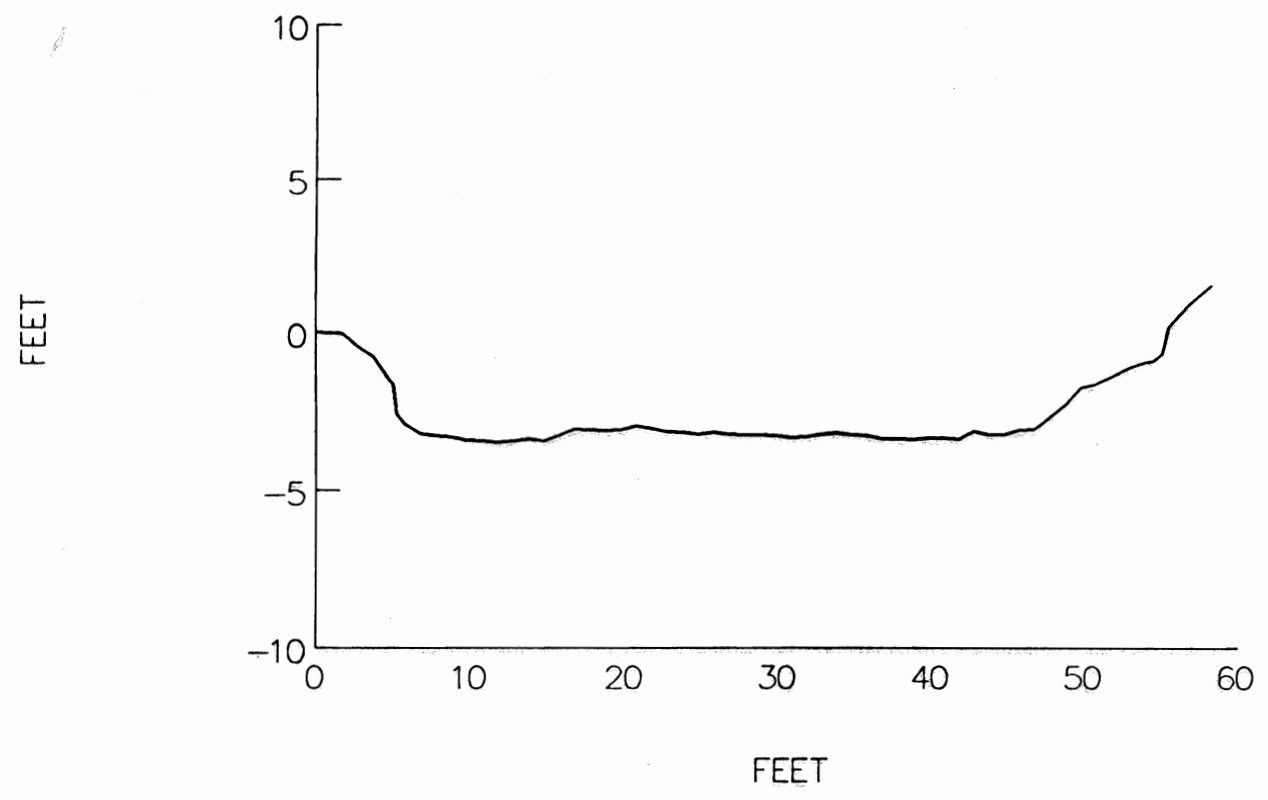
BALANCE SECTION 6
OWENS RIVER, 05/25/91
