REWATERING CHANNEL 10 IN THE RUSH CREEK BOTTOMLANDS, MONO COUNTY, CALIFORNIA

1995 Stream Restoration Program

Scott M. English
Stream Restoration Specialist
Northwest Biological Consulting
P.O. Box 671
Ashland, OR 97520
(541) 488-1061

December 1995

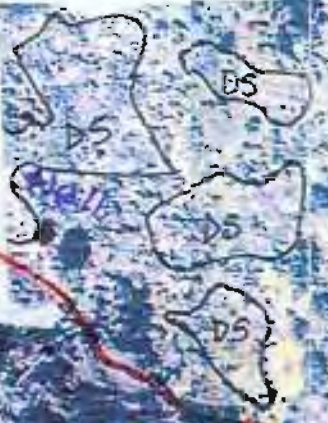
AERIAL
PHOTOGRAPH 1

Figure 1: Location of Rush Creek Pilot Project to Rewater Portions of Channel 10.

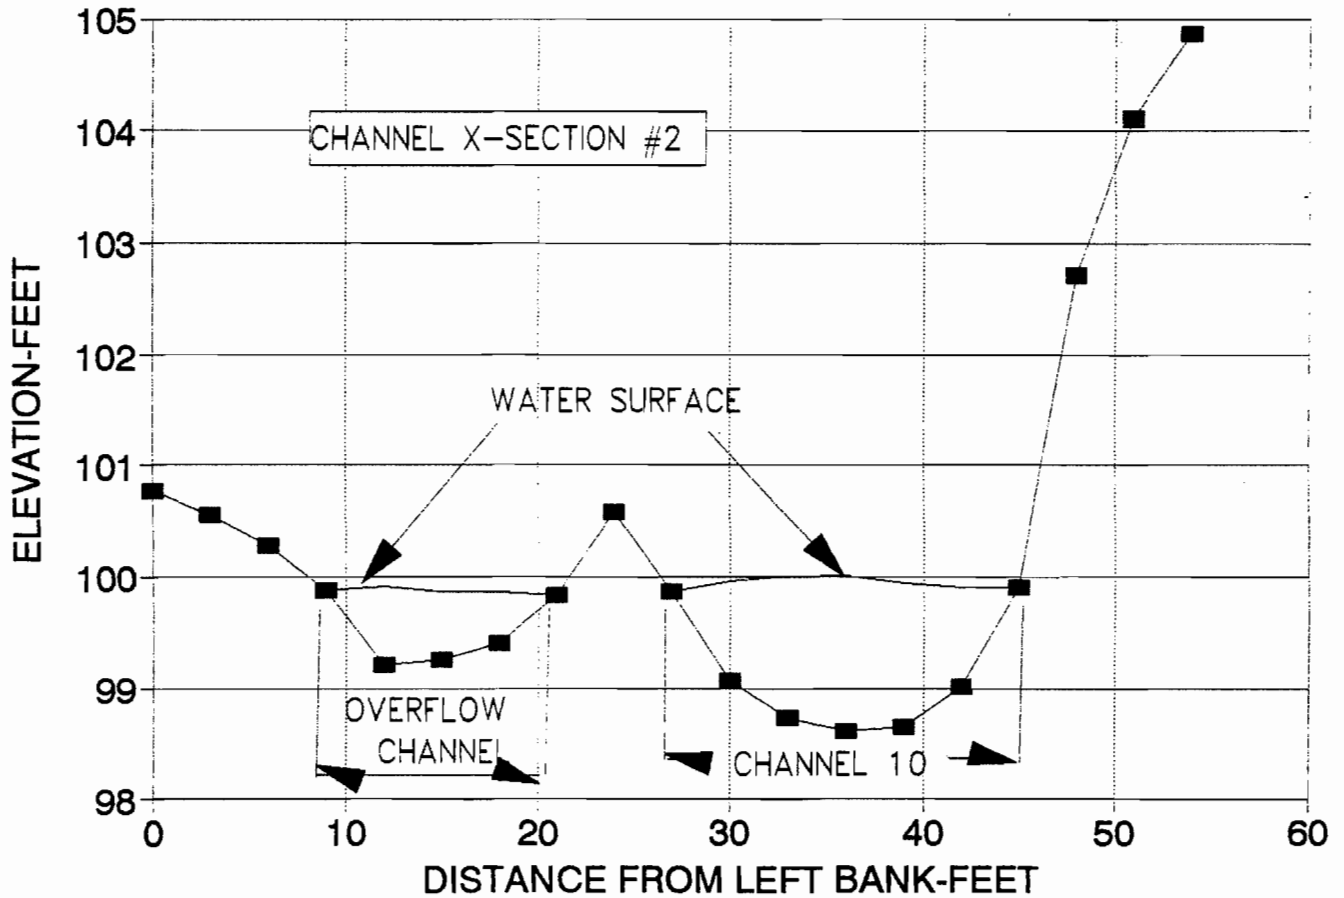
FIGURE 3

11/15/95 W.C.G. BYPASS CHANNEL X-SECTION #2 FILE XSECCW.WQ1

13. Approximately 40 CFS (2/3 of incoming flow) occupied Channel 10 and 20 CFS (1/3 of flow input) discharged into the overflow (side) channel. Please refer to Figures 2-8 for cross sections and profiles of Channel 10 and the overflow channel.

14. The overall gradient of the excavated channel was approximately ½ percent. The bed topography was fairly uniform and matched existing channel topography. (See Figures 2-8)

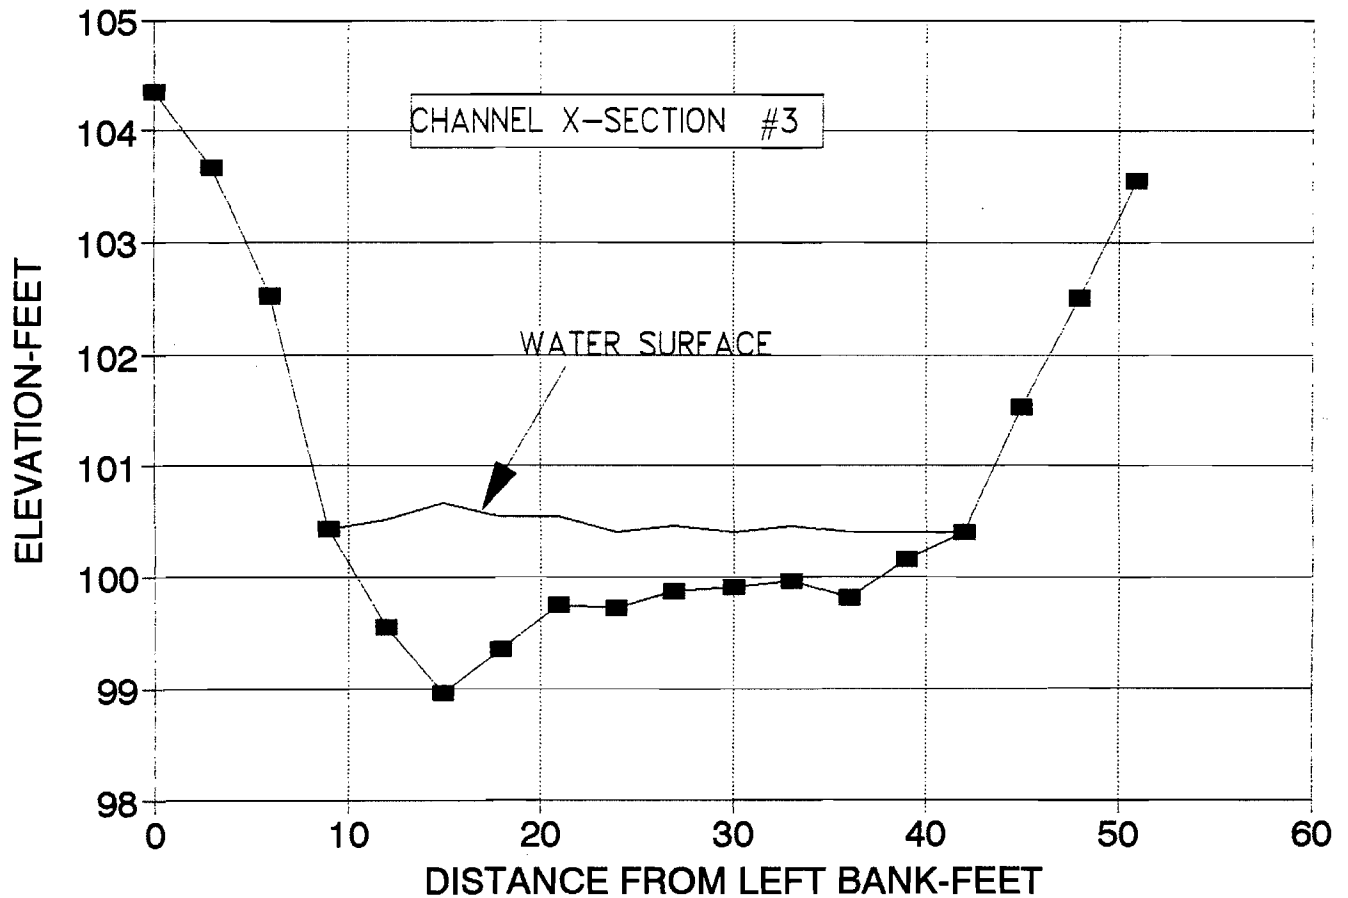
FIGURE 4

11/16/95 W.C.G. BYPASS CHANNEL X-SECTION #3 FILE XSECCW3.WQ1

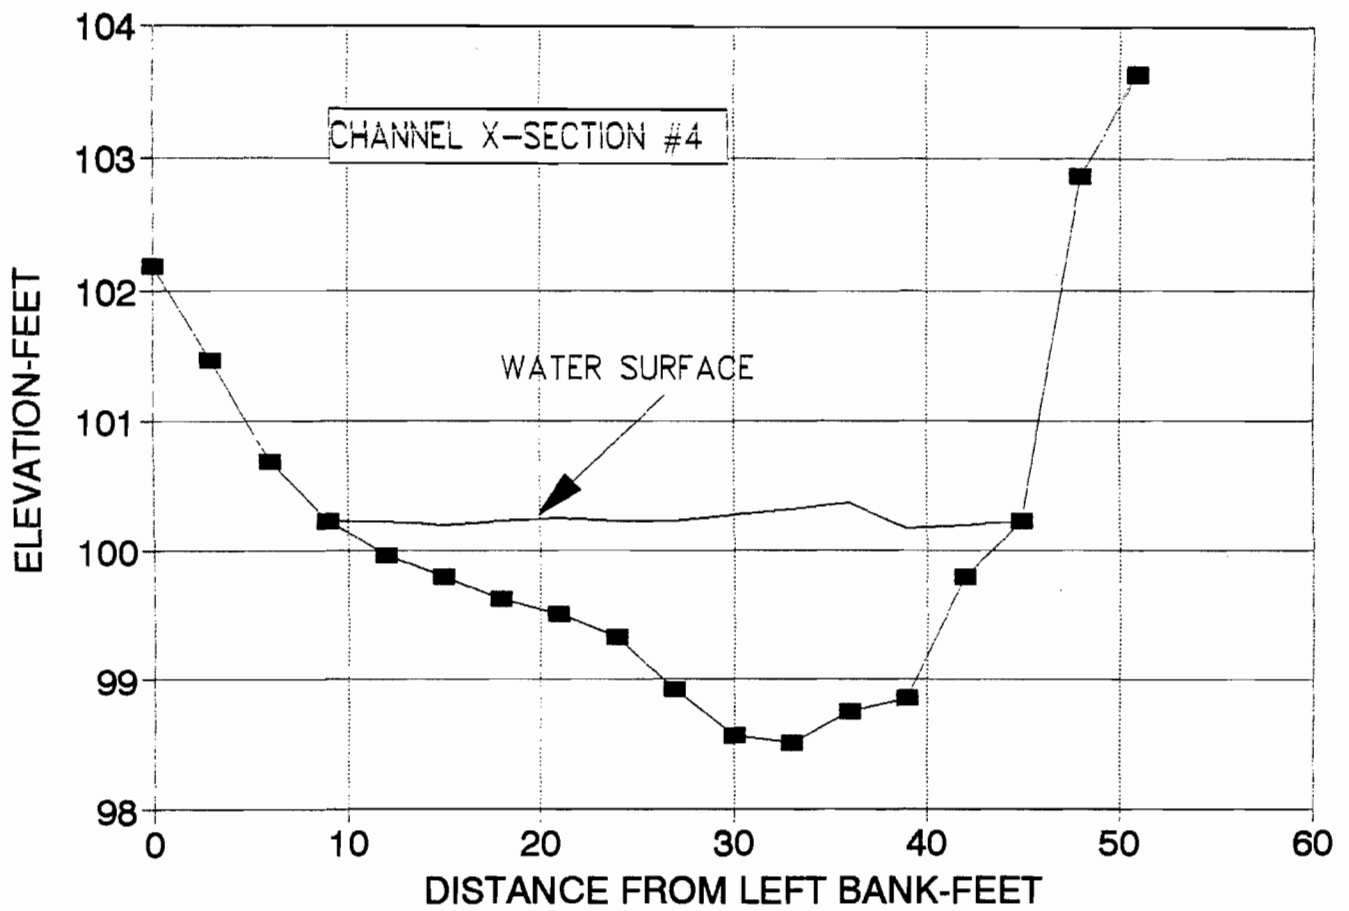
FIGURE 5

11/17/95 W.C.G. BYPASS CHANNEL X-SECTION #4 FILE XSECCW4.WQ1

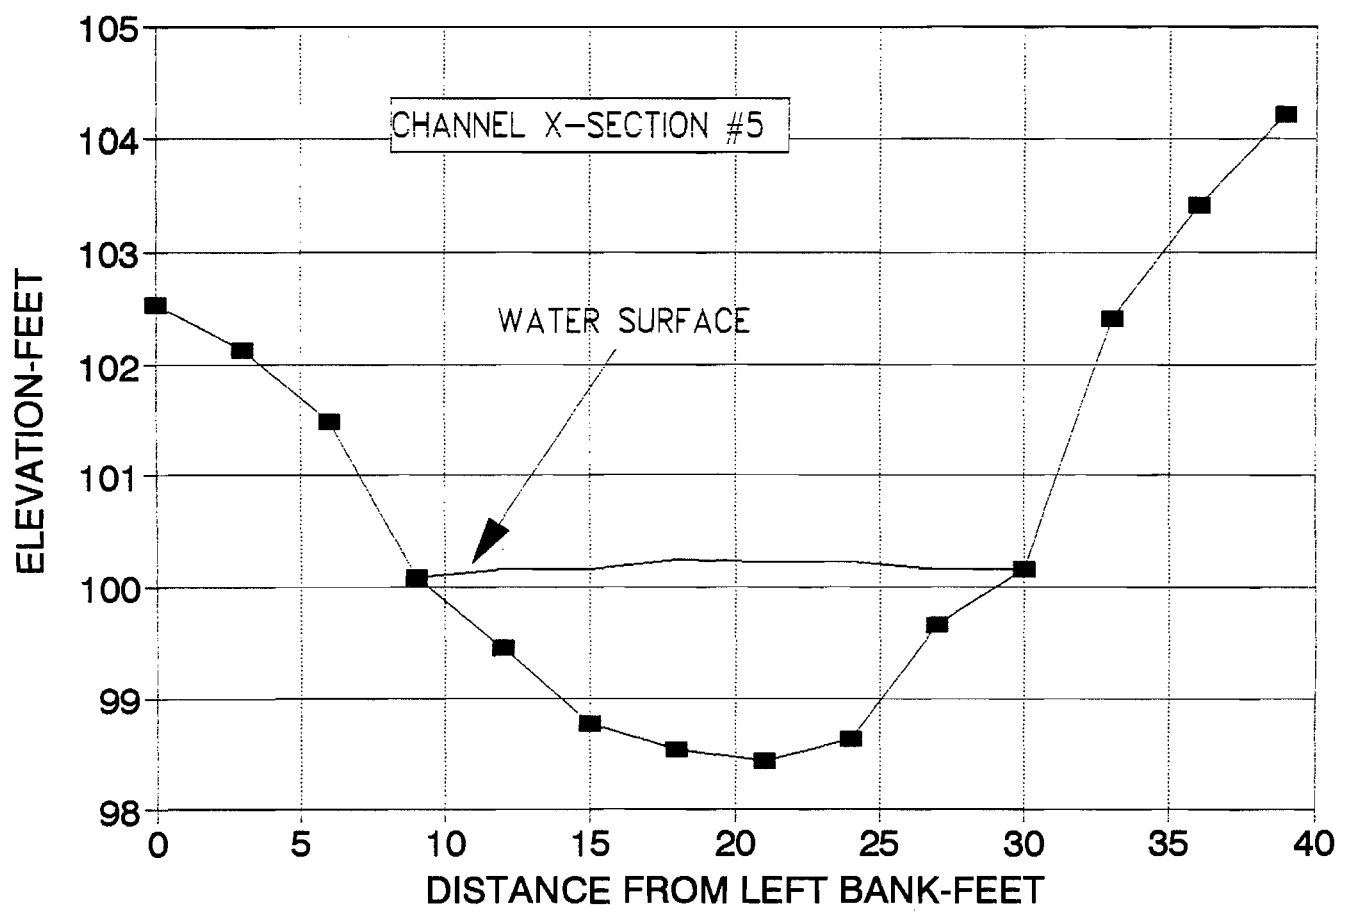
FIGURE 6

11/17/95 W.C.G. BYPASS CHANNEL X-SECTION #5 FILE XSECCW5.WQ1

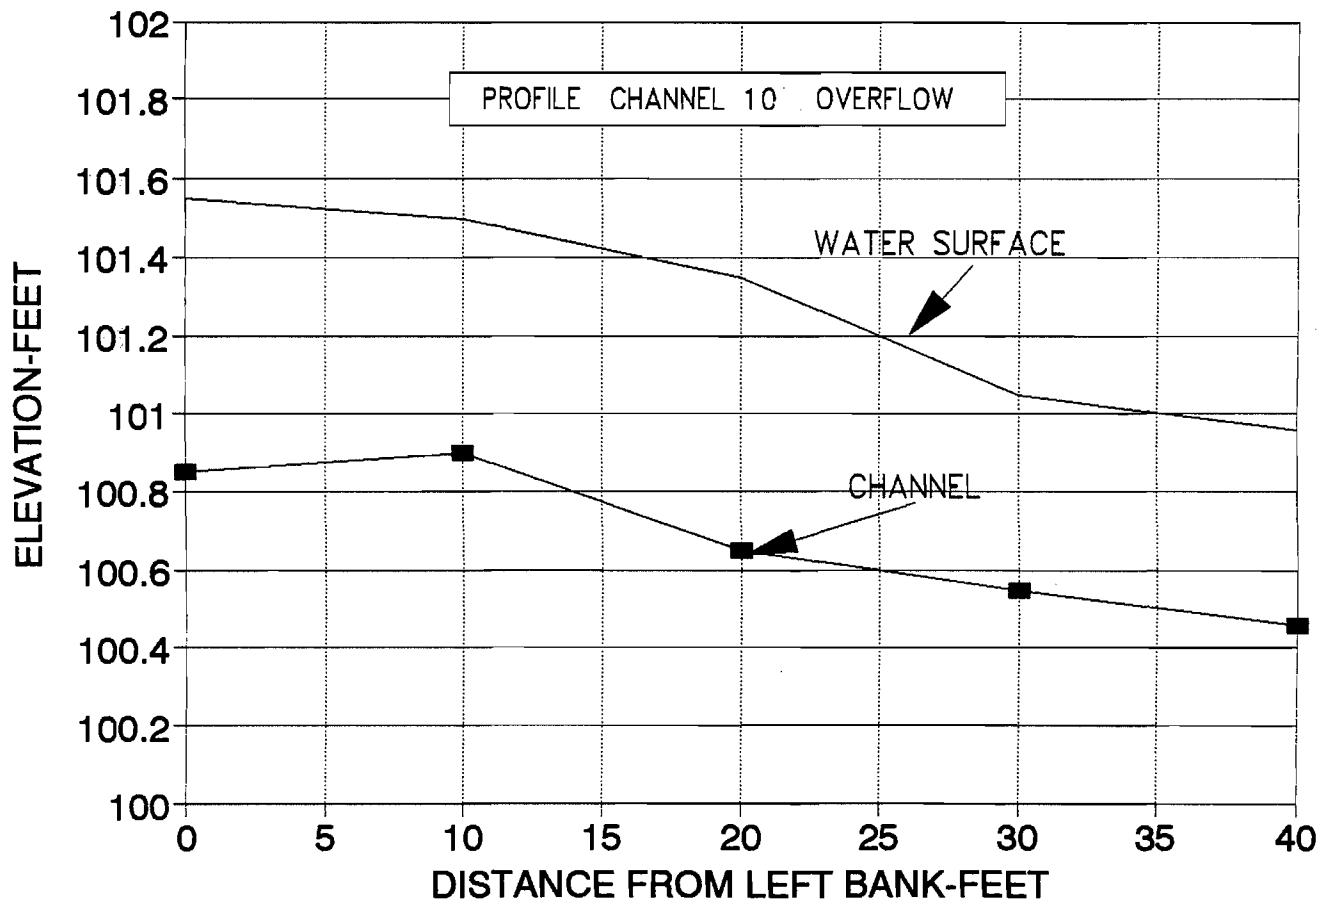
FIGURE 8

11/18/95 W.C.G. PROFILE OVERFLOW CHANNEL FILE PROFILES.WQ1

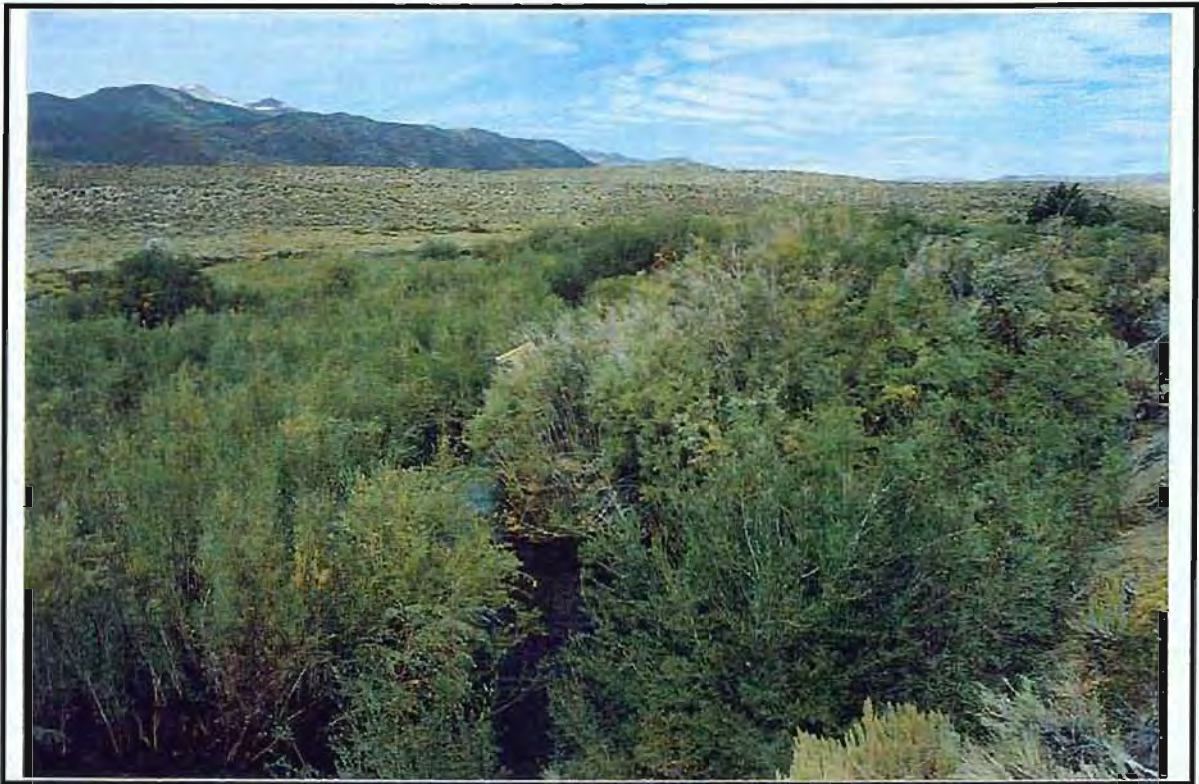
PP1a Before: Upstream end of project before large gravel & debris plug was removed from the initial 450 ft. of the historical Channel 10. The existing side channel of Rush Creek has an estimated discharge of 60 CFS.

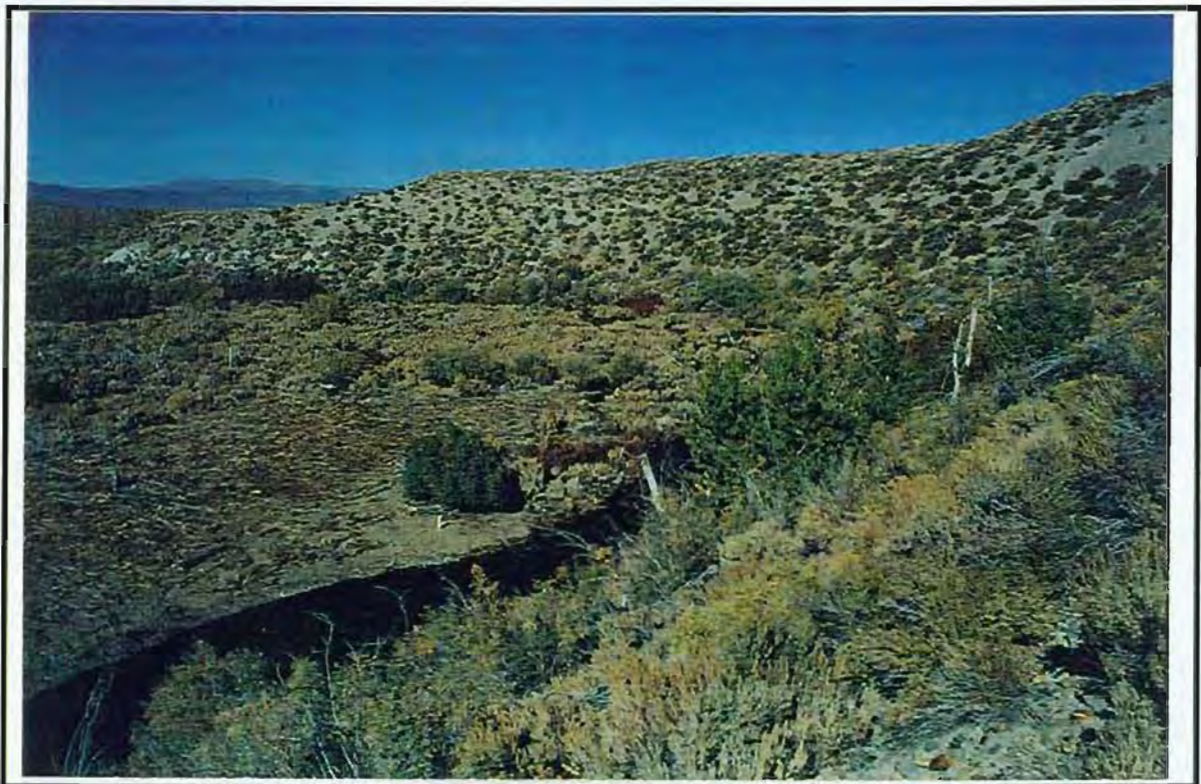
After: The upper section of Channel 10 after the sediment plug was removed and the channel rewatered with ~40 CFS. One of six piezometers is located next to the willow, along the left bank of Channel 10.

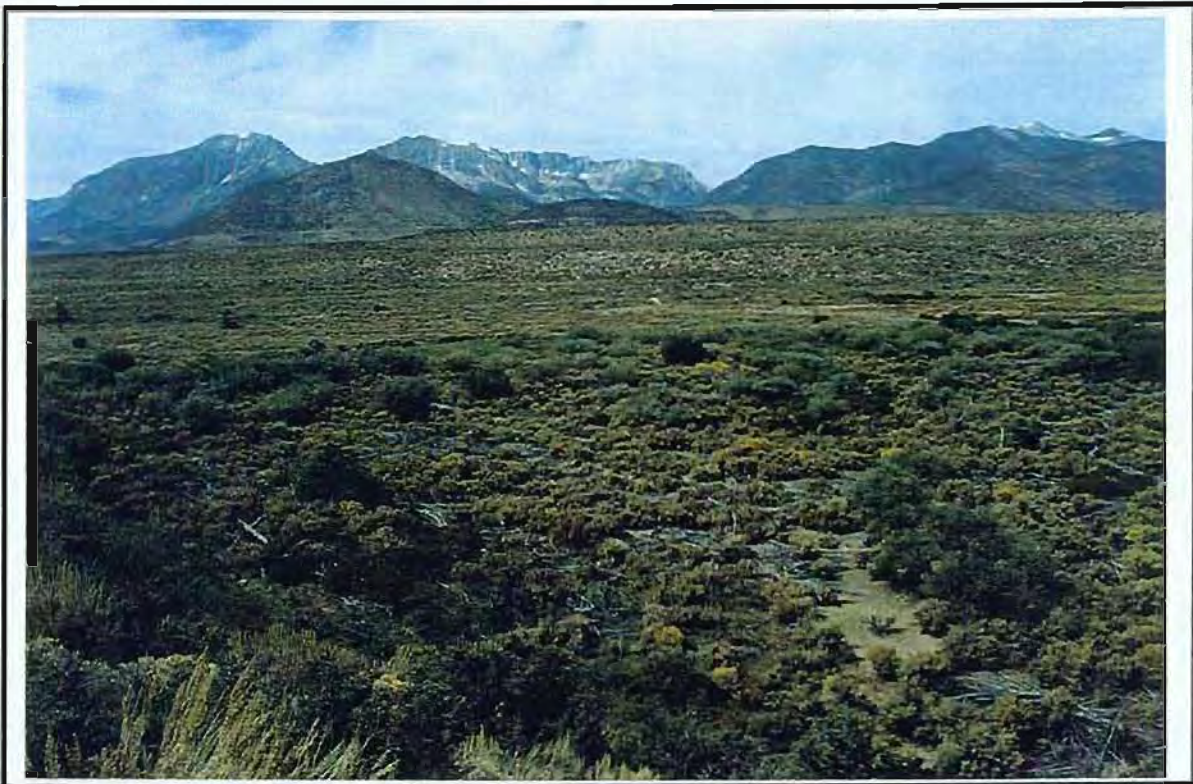
PP4 Before: Upstream view overlooking sediment/debris plug of Channel 10. Approximately 3 to 6 feet of plug materials were excavated & removed from ~450 lineal feet of upper stream channel. Sagebrush and rabbitbrush vegetation was growing over much of the historical channel and adjacent areas.

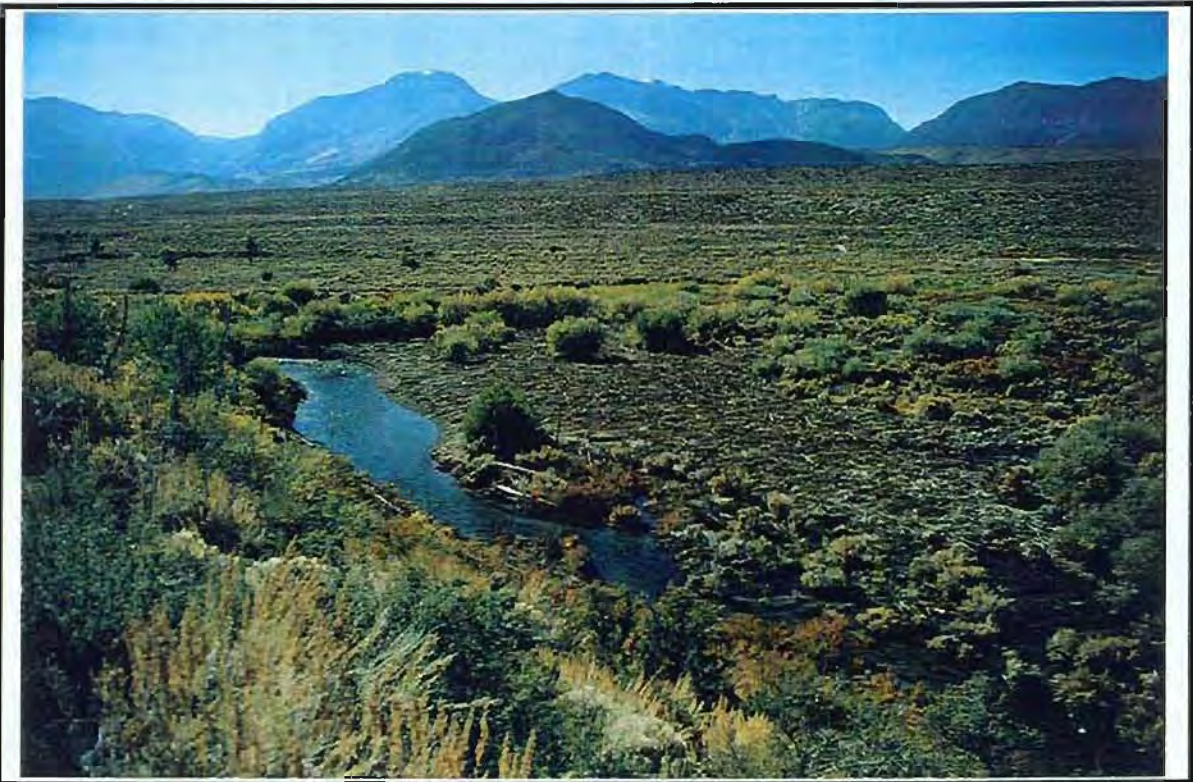
After: View looking upstream along the toe of the valley wall depicting the ~450 ft of constructed Channel 10. ~1500 yds³ of plug sediments/debris were removed and placed on the adjacent area which impacted ~1 acre of upland sagebrush and rabbitbrush vegetation. The impacted area was seeded with the same native uplandl vegetation. Existing willows were mostly left in tact. Brush was scattered over the area to hold the seeds in place and reduce wind erosion on the site.

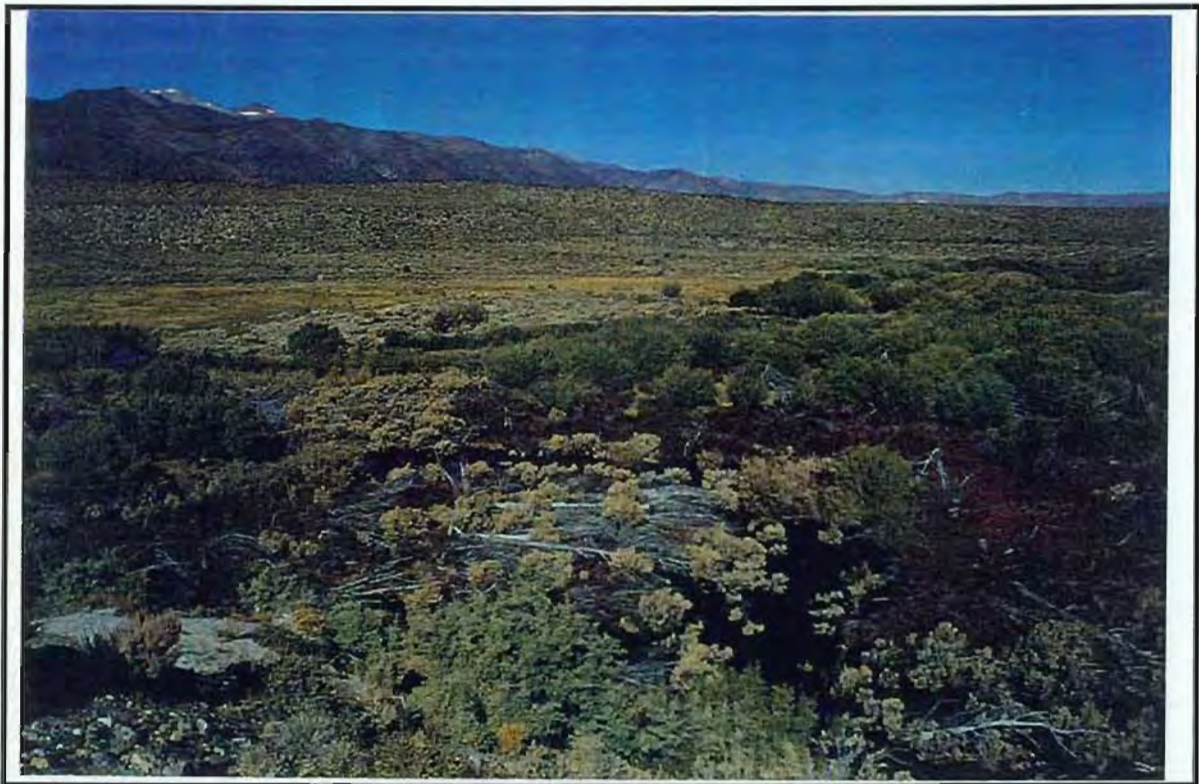
After: The rewatered Channel 10 as it flows around the toe of the valley wall. No channel work was required here. The 40 CFS flow occupied the historical stream planform and streambed topography.

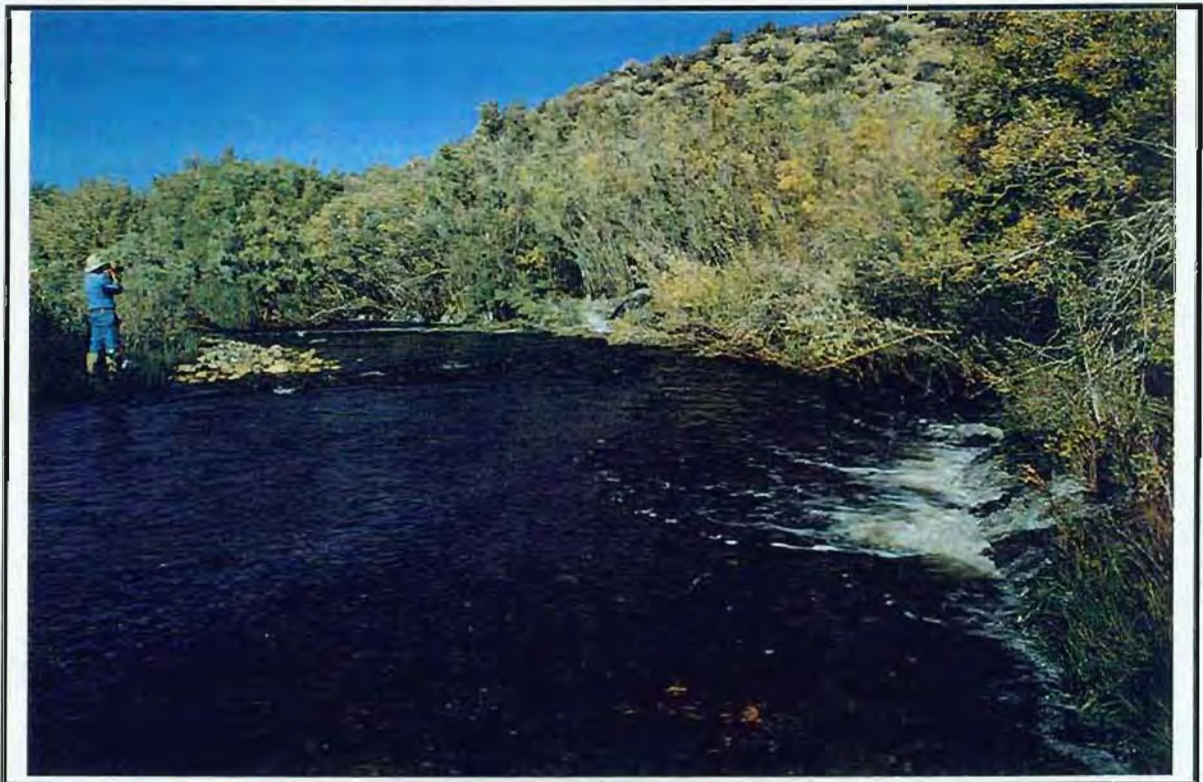
After: The photograph depicts the confluence of Channel 10 with the main channel of Rush Creek. The 40 CFS flow from Channel 10 enters the main channel at several points along the right bank. The dominant flow enters in the foreground. The configuration could change in time.

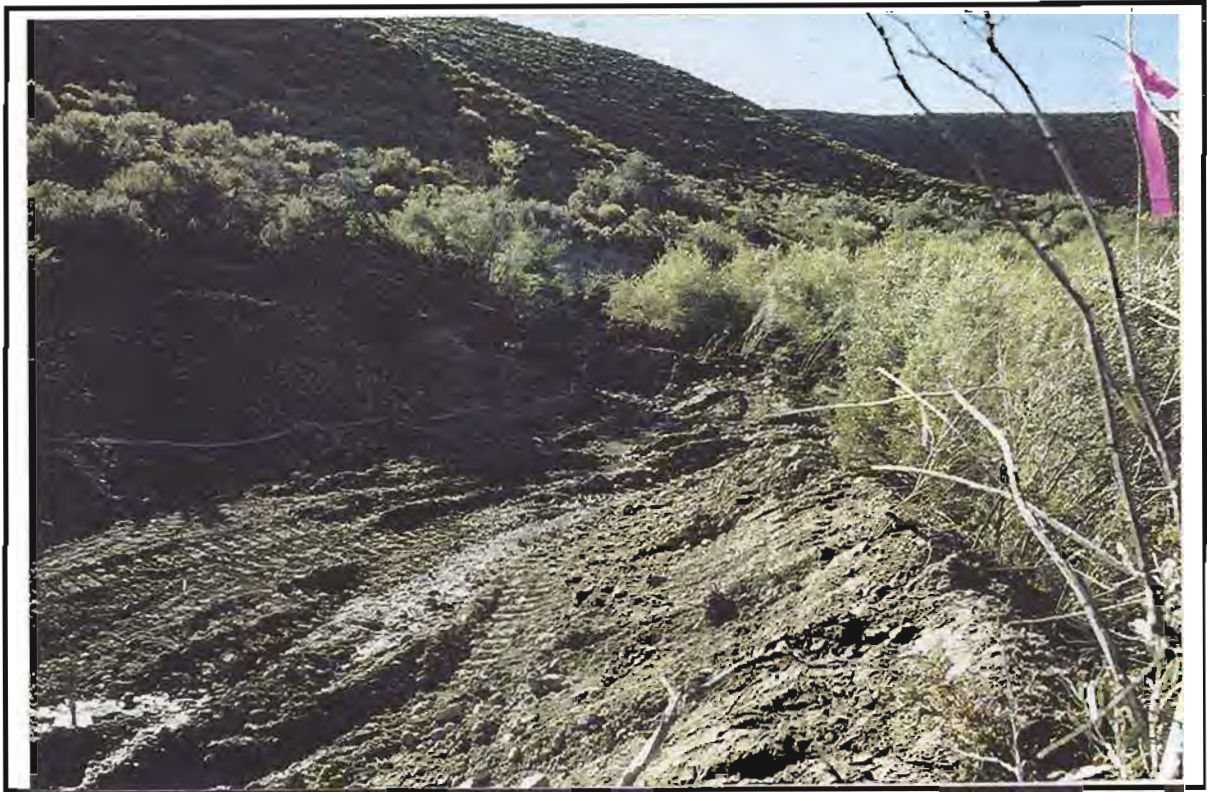
Before: Upstream view of entrance to Channel 10 during construction. Channel 10 is approximately 2000 feet in length.

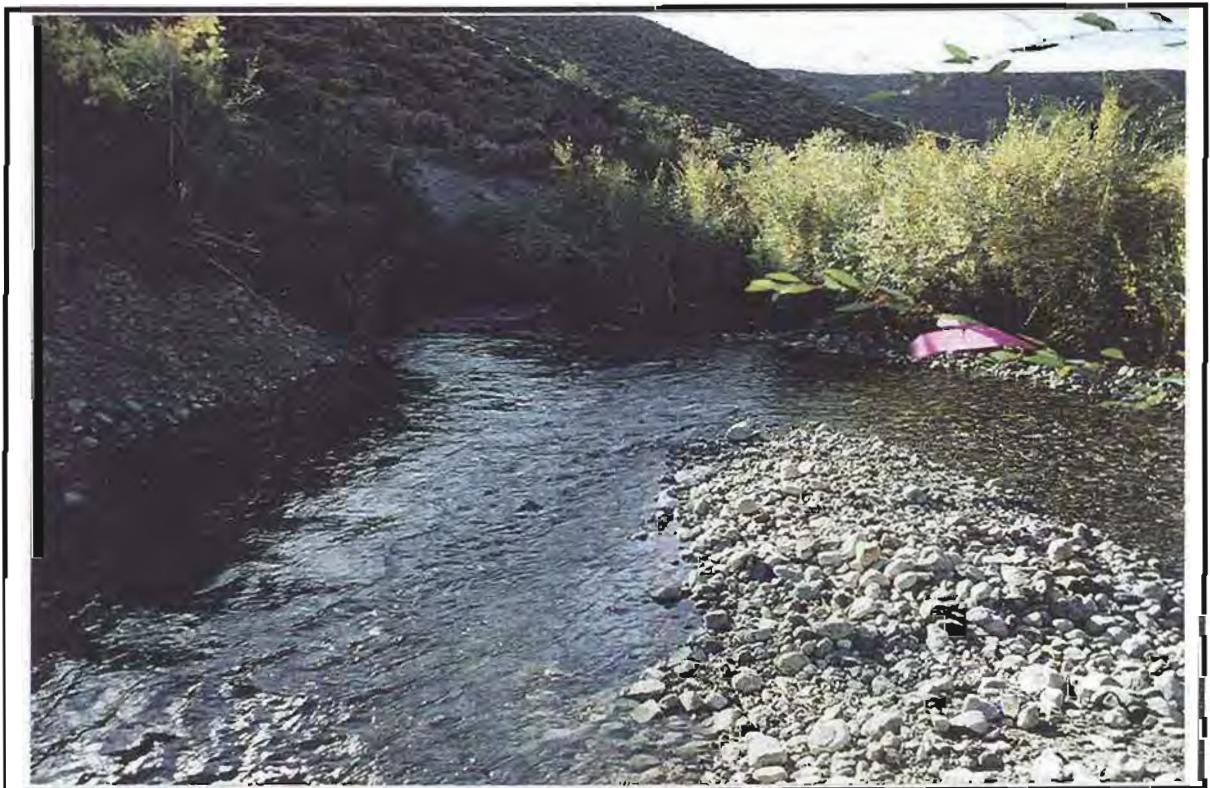
After: Photograph depicts the final configuration of the constructed point bar. The smaller right channel is the existing side channel and the left channel is the constructed Channel 10 entrance. Channel 10 is designed to contain $\frac{2}{3}$ of the incoming flow & the side channel will contain the remaining $\frac{1}{3}$ and function as an overflow channel.

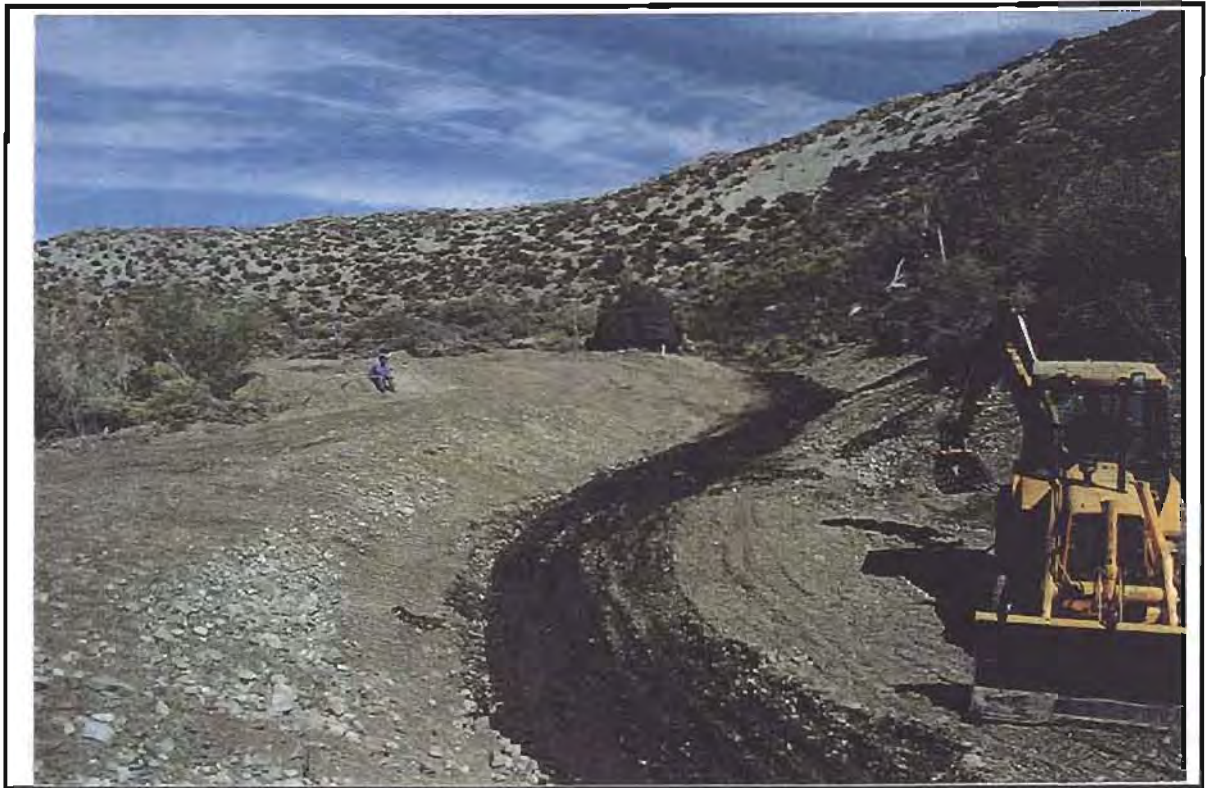
Before: Photograph depicts excavation/construction underway just downstream from the entrance to Channel 10. Removal of the gravel/debris plug took place from the entrance to a point 450 feet downstream.

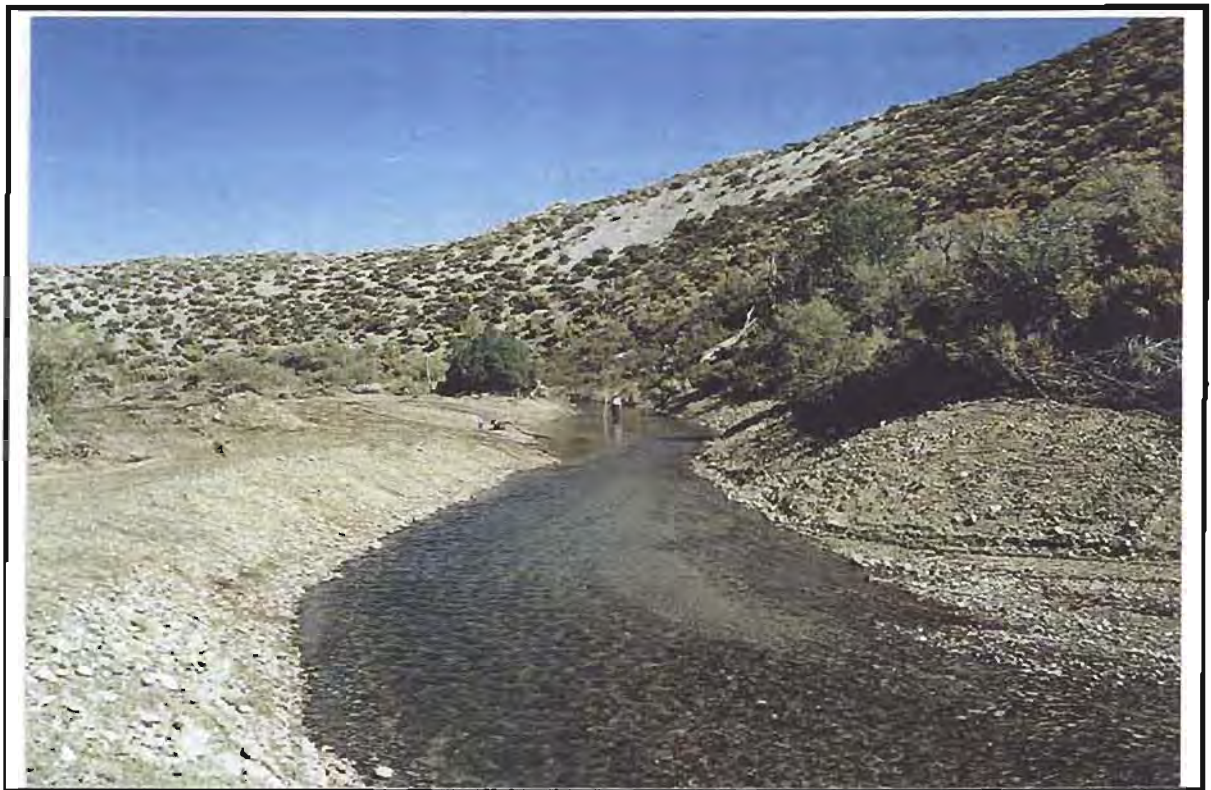
After: View of the constructed channel. Sloping, armored streambanks and point bars were constructed along a planform which followed the toe of the valley wall. After the revegetation of the banks the channel is expected to remain relatively stable through a range of discharges.

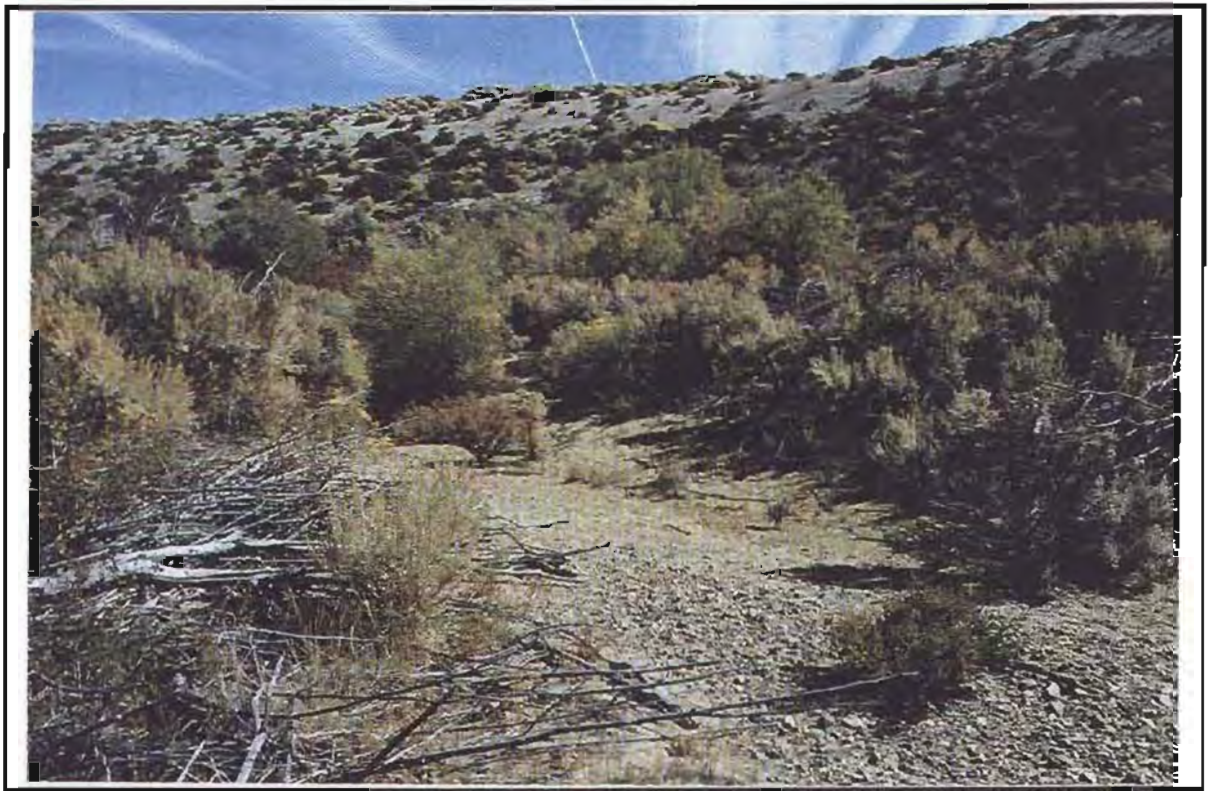
Before: Photograph depicts historical Channel 10 approximately 600 feet downstream from channel entrance. No channel work was done from station 4 + 50 to station 20 + 00.

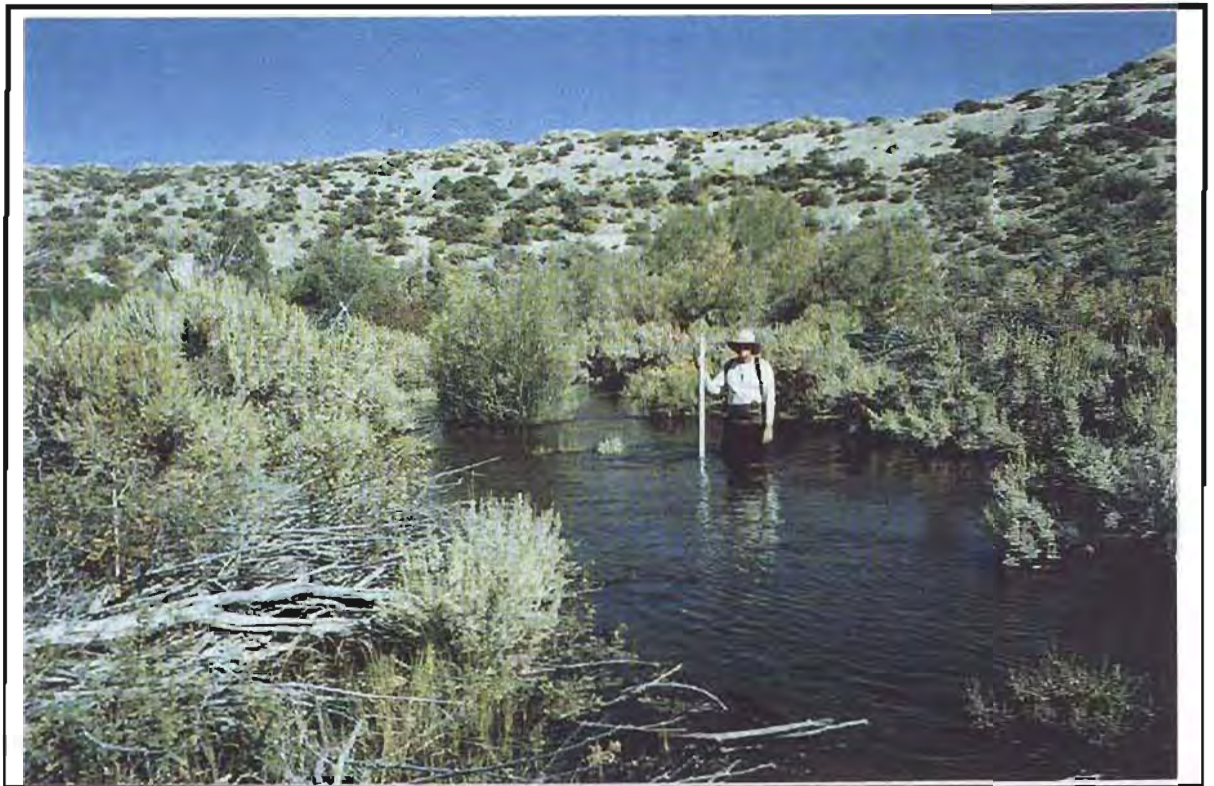
After: View of rewatered channel with ~40 CFS. The channel follows the toe of the valley wall for most of its' 2000 foot length. The channel is approximately 22 feet wide and 2 1/2 feet deep.

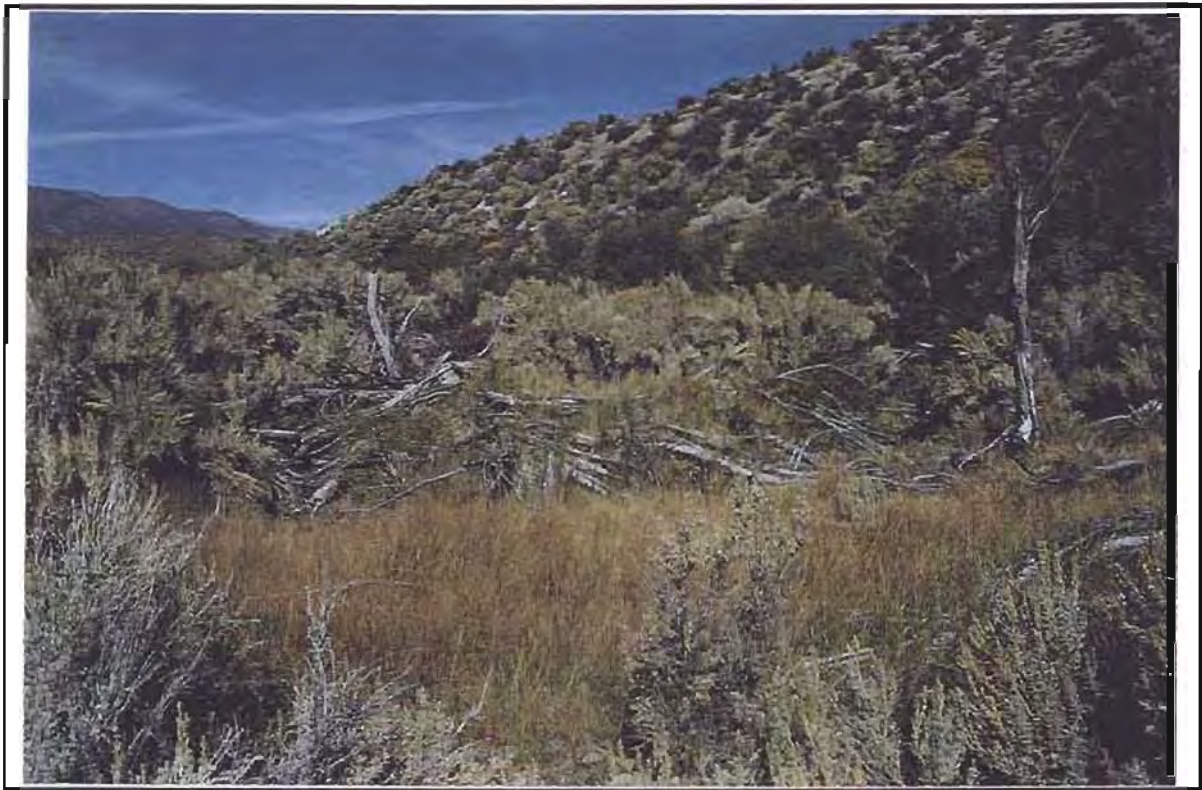
Before: Depiction of dry historical channel approximately 800 feet downstream from entrance.

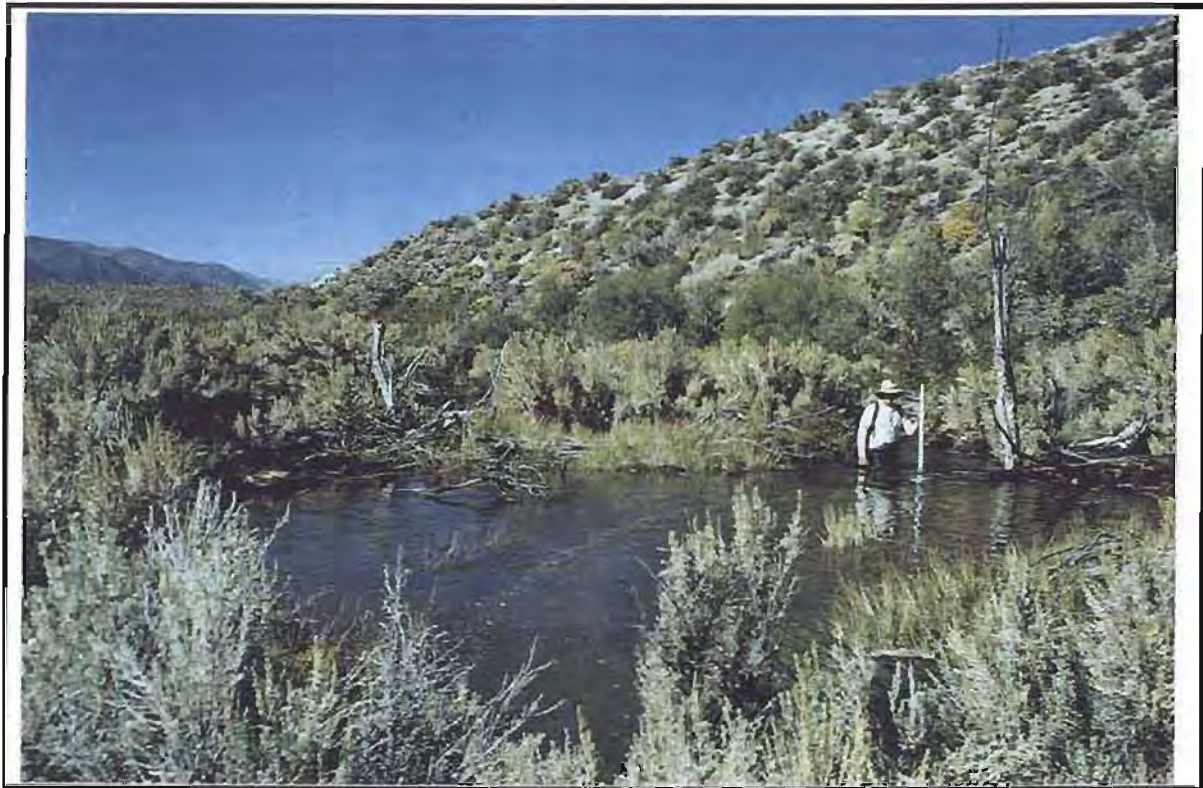
After: Rewatered channel with ~40 CFS. Most of the habitat appears to be deep glides and pools with depths varying between 2 & 4 feet and with velocities of approximately 1-2 FPS. Waterfowl were seen utilizing this habitat.

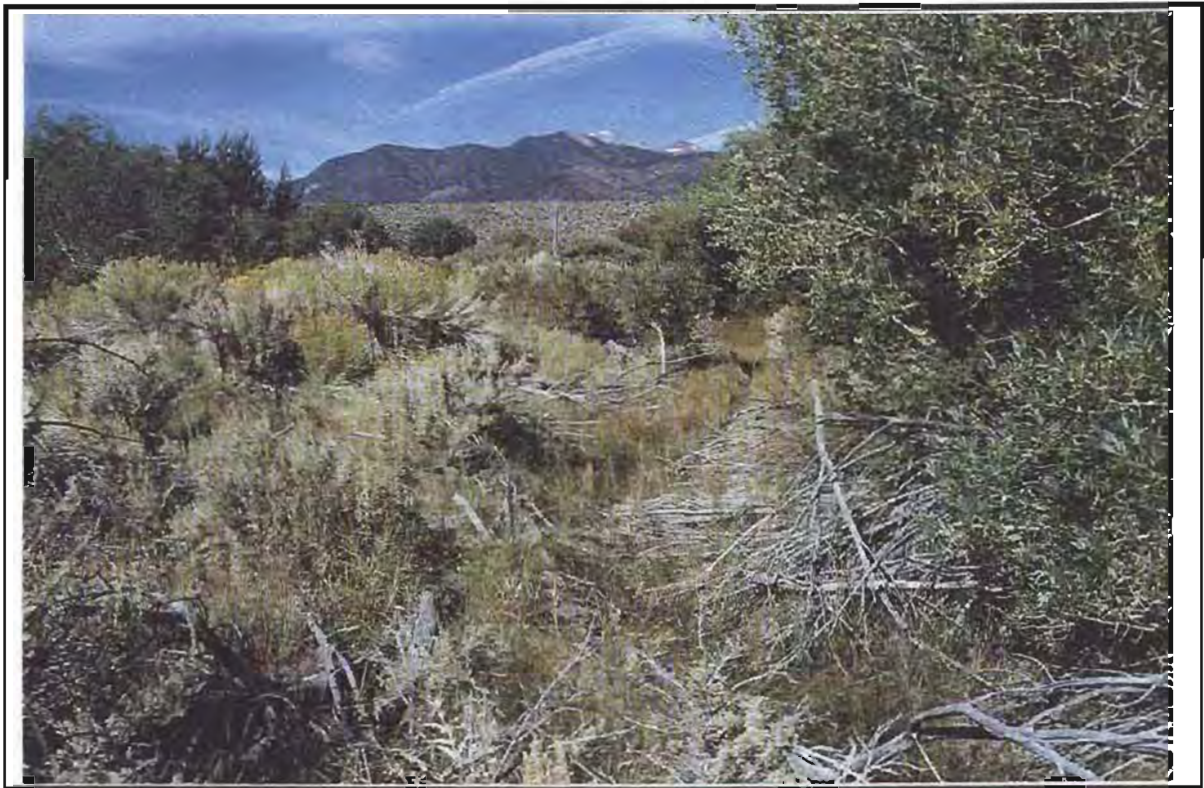
Before: Historical Channel 10 approximately 1000 feet downstream from channel entrance.

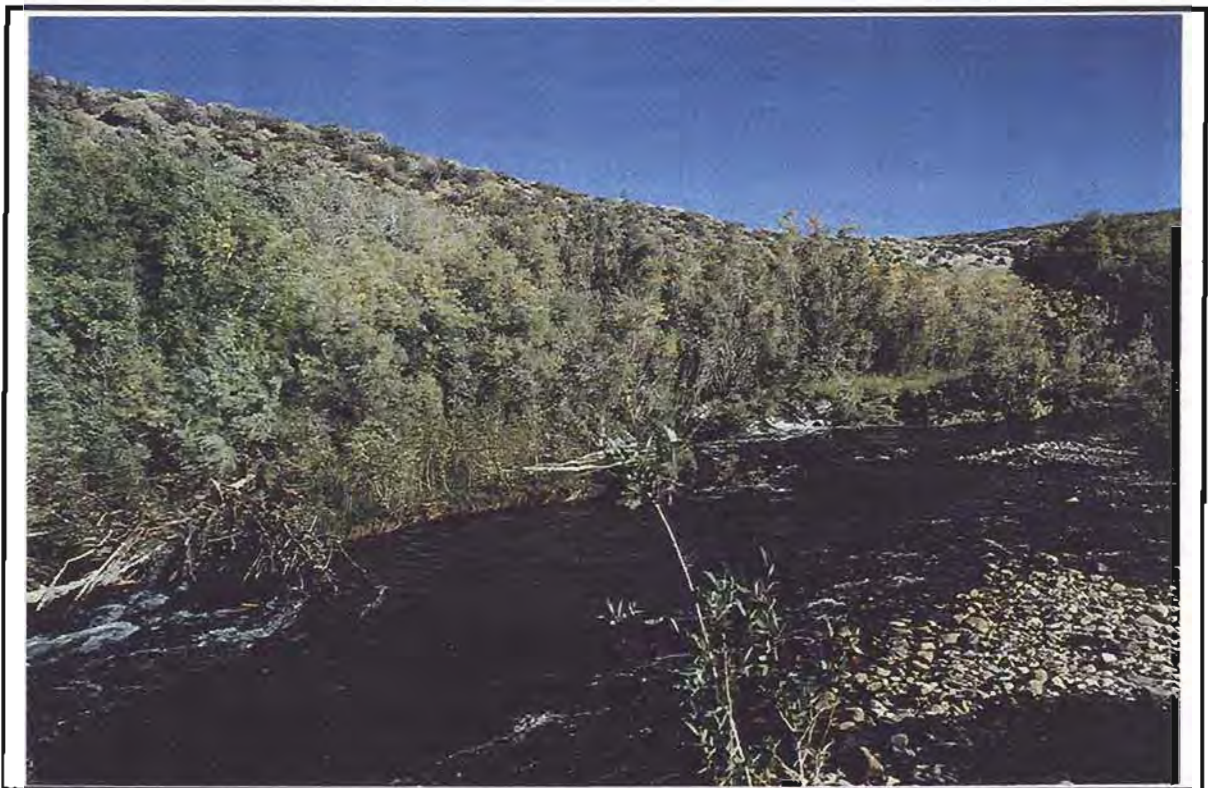
Before: View of main channel of Rush Creek. The confluence of Channel 10 is on the left.
