REWATERING CHANNEL 10 IN THE RUSH CREEK BOTTOMLANDS, MONO COUNTY, CALIFORNIA

1995 Stream Restoration Program

Scott M. English
Stream Restoration Specialist
Northwest Biological Consulting
P.O. Box 671
Ashland, OR 97520
(541) 488-1061

December 1995

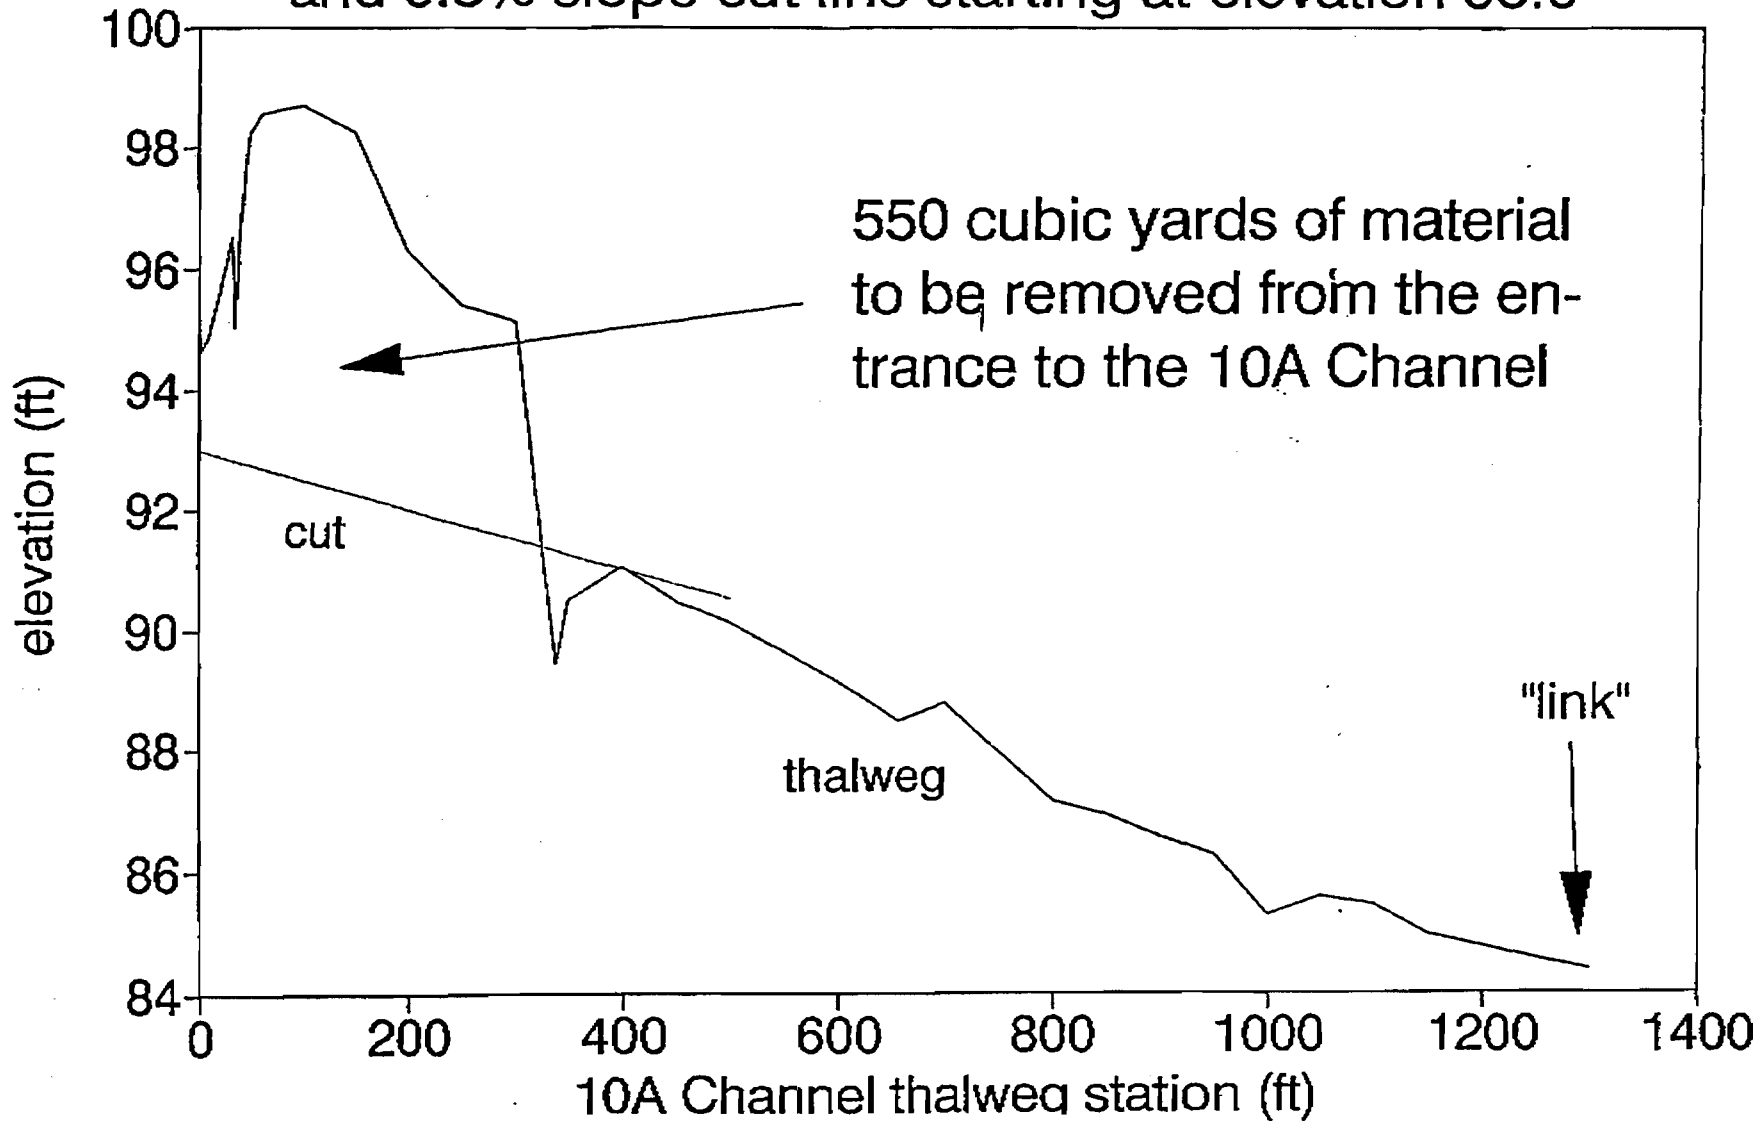
FIGURE 2

10A Channel longitudinal thalweg profile from the entrance to the "link"
and 0.5% slope cut line starting at elevation 93.0

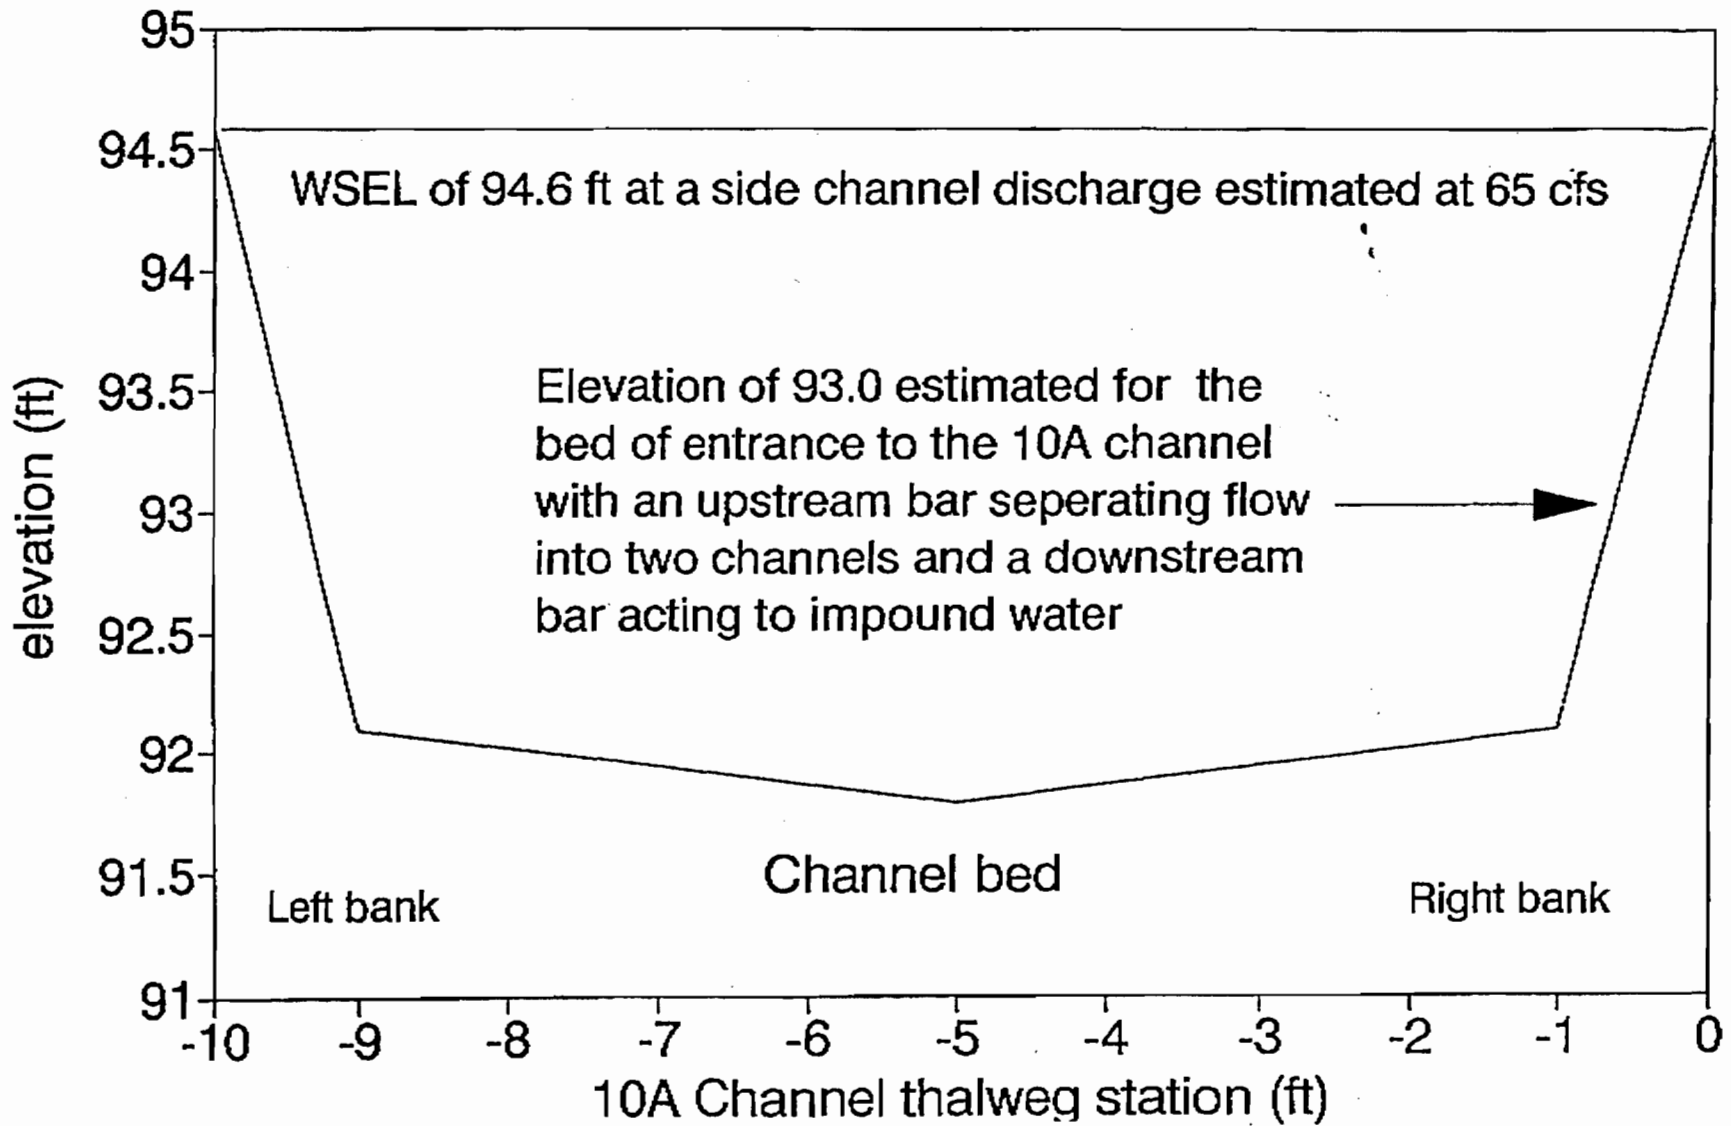
FIGURE 3

Estimated side channel cross section at the entrance to the 10A Channel

- The entrance to the channel system is designed for a flow of approximately 5 CFS at the stipulated flow of 47 CFS in Rush Creek during the summer of a normal runoff year. A bar and pool would be constructed in Rush Creek (side channel) to provide appropriate hydraulic conditions at the entrance to the 10A Channel. The upstream bar would separate the flow into two channels (Rush Creek Side Channel and 10A Channel) and a constructed downstream bar on Rush Creek Side Channel would help control the water level (Figure 3).

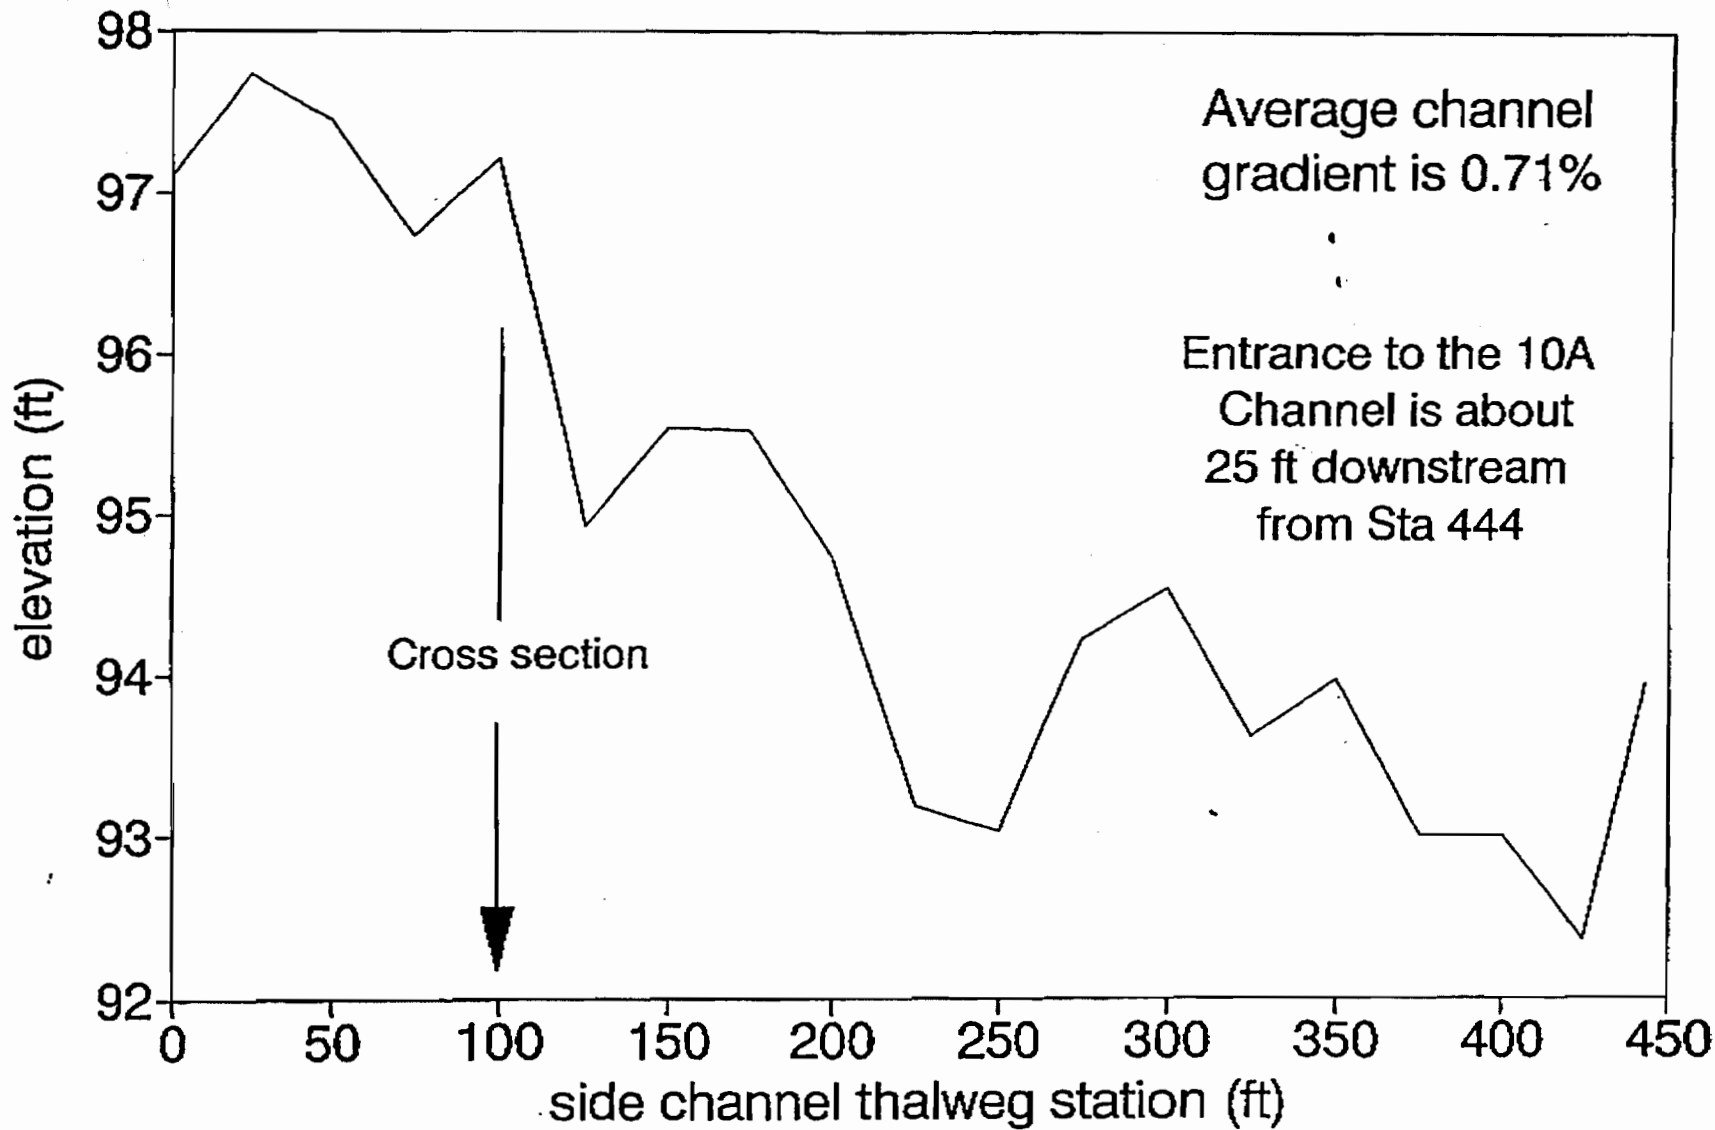
FIGURE 4

Side channel longitudinal profile from Rush Creek to near the 10A entrance
